Town of Middleton

Facility Assessment and Capital Planning- Final submission

Eagle Project Management Inc.

Facilities Assessment and Capital Planning

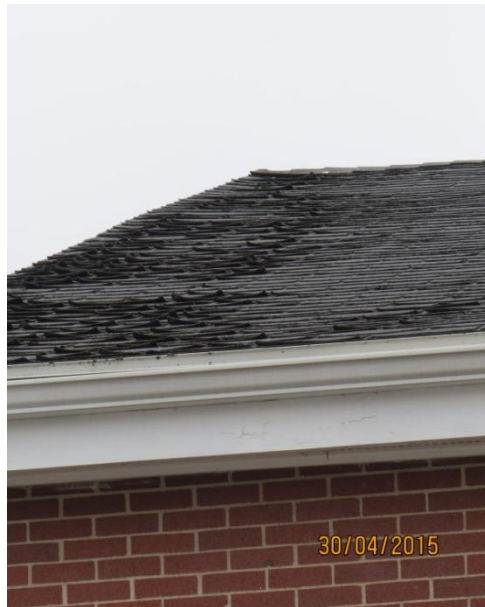
1.1 existing shingles are in poor condition and need replacement

Typical roof condition
Estimated cost: \$ 14-16,000

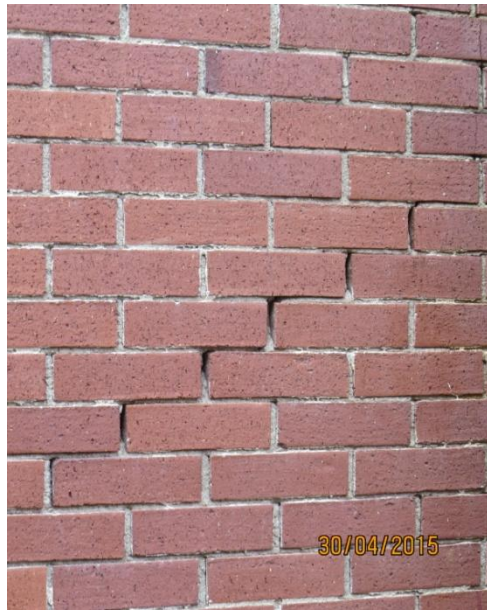
2.1 The walls are constructed of a mixture of brick and concrete materials with minor cracks and deflections.

East side

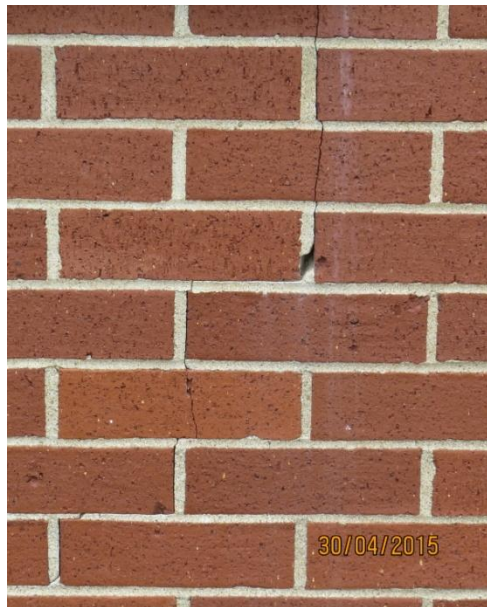
East side near north front corner
Estimated cost to repair: \$ 5-6,000

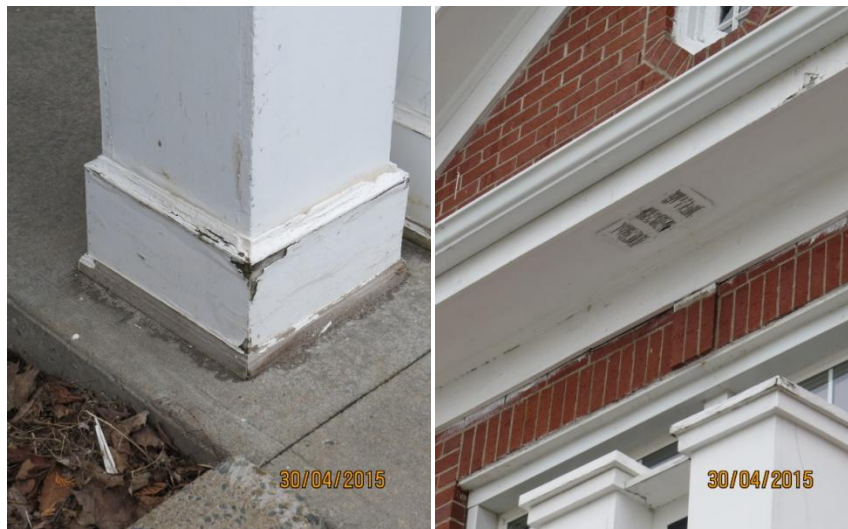
- 7.2.1 Wood structures require painting. Front elevation columns and decorative works do not contain moisture relief drainage causing paint to prematurely flake off the wood products. Ensure moisture release holes are installed, scrap, clean and prime all areas with alkaline based paints. Previous paint products may contain lead based products- latex paints will not bond properly to lead based products.

Damaged front entry column

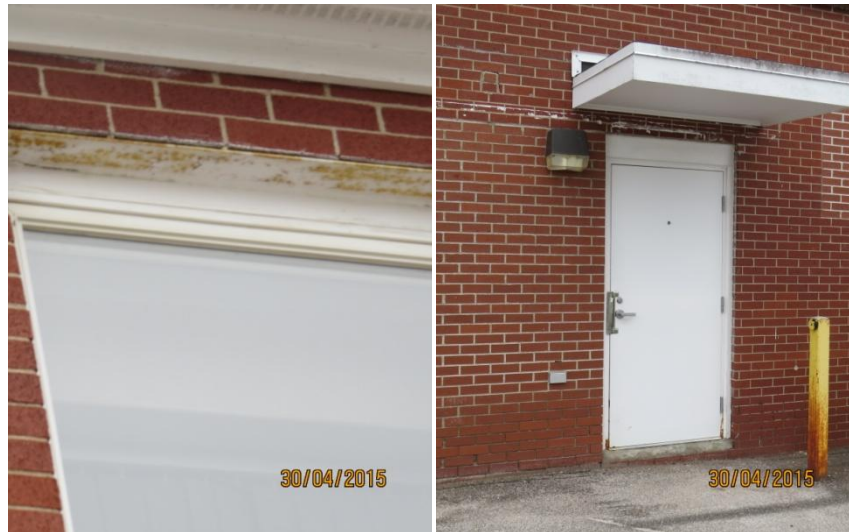
8.1.2 The RCMP employee entrance is in similar condition as the public entrance. However; the door operation appears to be working normal.

RCMP employee entrance- door and frame repairs

Estimated cost to repair, replace 2 doors, repair masonry, painting and finishing,
\$ 10,500.00

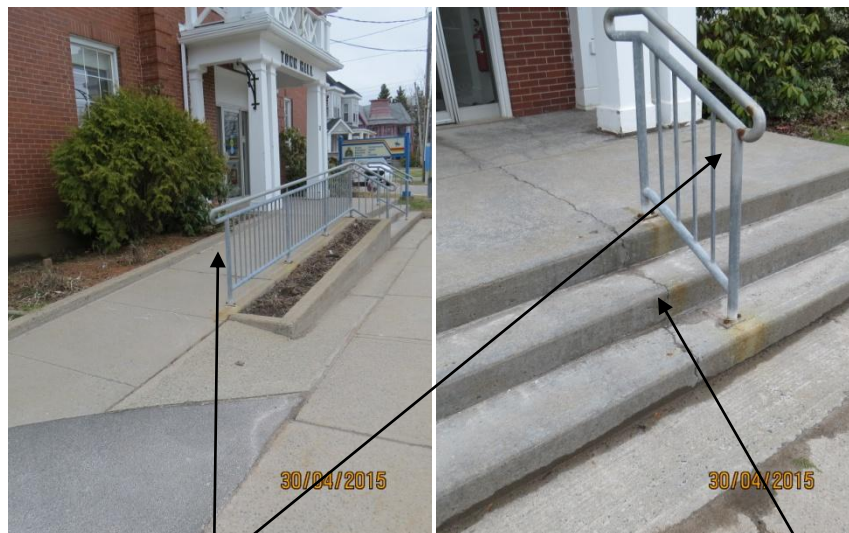
9.1 The exterior main entry contains an accessible ramp system but does require some modifications to meet the current NBC. Handrails shall extend 300 mm beyond the step and be install parallel to the ground surface. Cracks in walking surface pose hazards to mobility impaired.

Extend handrails

repair cracks and surfaces

Estimated cost to repair \$ 500.00

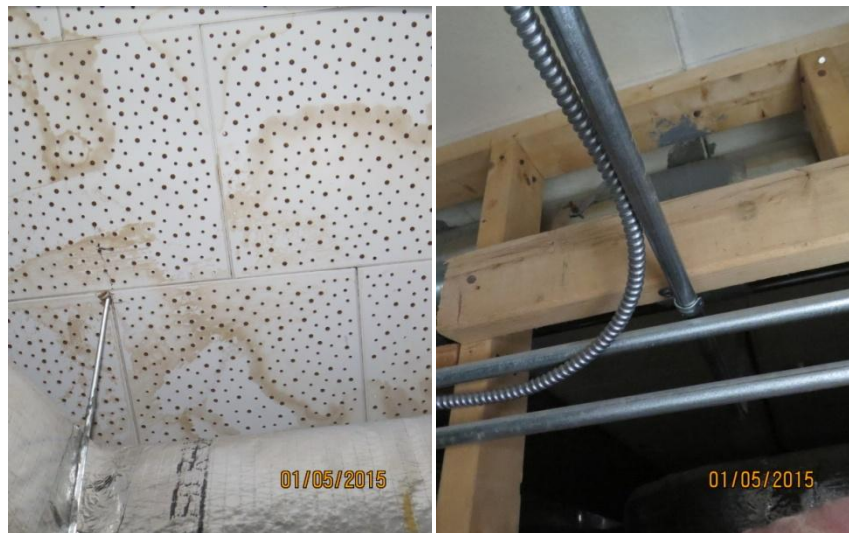
- 10.3 The building is primarily wood construction with brick exterior. There is no fire separation between the floors, the stair and exit system are not fire rated, between the floor and between adjoining rooms are not fire sealed, between the upper floor main hallway means of egress and the upper floor egress door are not fire rated or sealed. The upper floor means of egress is partly blocked with a moveable office partition which may cause blockage during a fire escape- removal required. The upper floor contains two ceiling elevations, the exposed lower suspended ceiling and the original pressed tile upper ceiling. The upper ceiling contains several areas of historic water leaks. The upper ceiling areas should be checked for mold and asbestos products considering the age and condition.

Area above upper floor ceiling, water leaks (roof leaks) on upper ceiling tile, upper ceiling tile may contain asbestos, means of egress halls not fire separated or sealed

Estimated cost to repair \$ 165,000

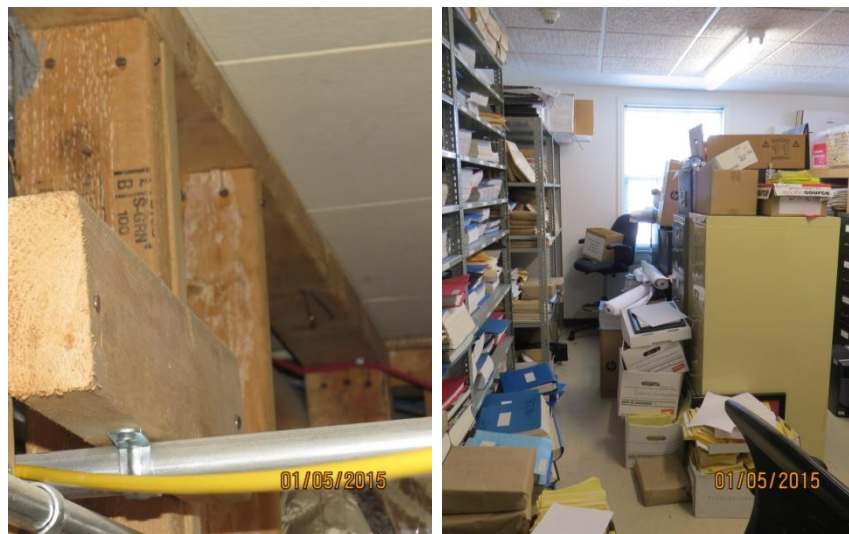
At Council Chambers, hall side,
Not fire sealed

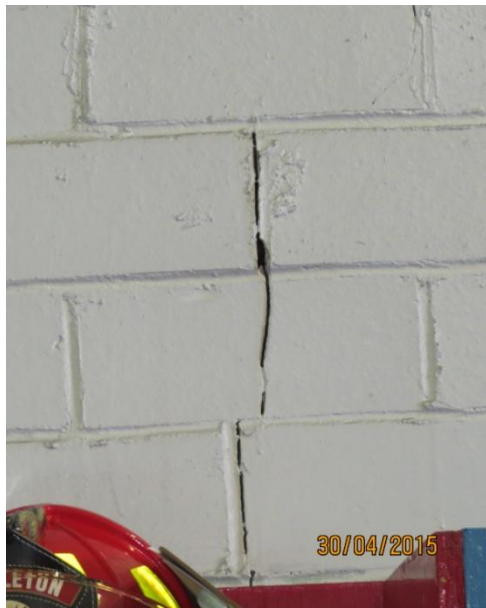
Typical structural crack

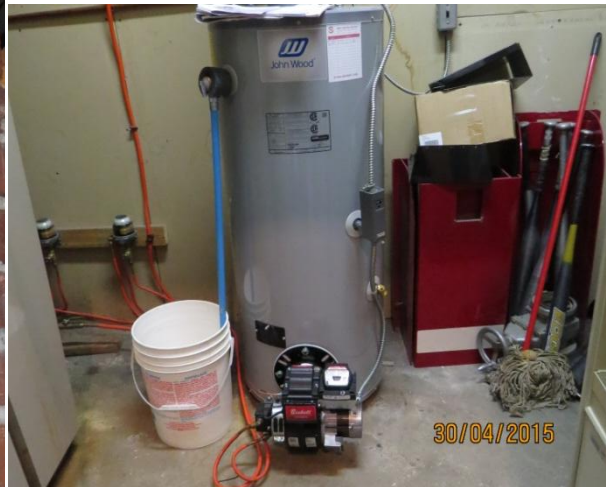
The heating system is hot water baseboard oil fired, a single heating boiler and a single 60 gallon how water tank are located within the boiler room. The majority of the piping system is not insulated generating great heat loss during operations. The chimney is leaking creosote from the boiler operations; the 2x 909 litre fuel storage tanks are located on the west side of the property between this property and the Town hall property near the main entry to the fire hall.

John Wood 60 gallon hot water tank

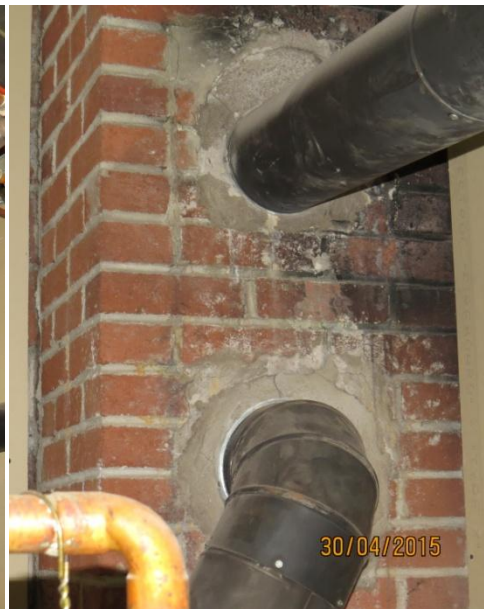
boiler exhaust leaking

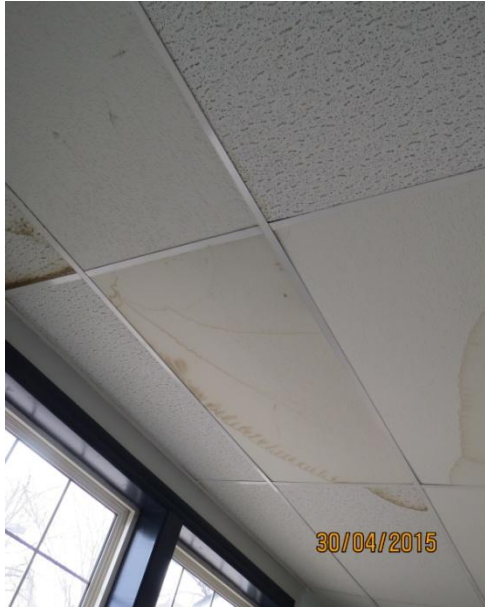
The suspended ceiling, near the north corner contains a substantial roof leak area very visible. The south end storage room ceilings contain several stains from past roof leaks.

Ceiling tile damage- leak above

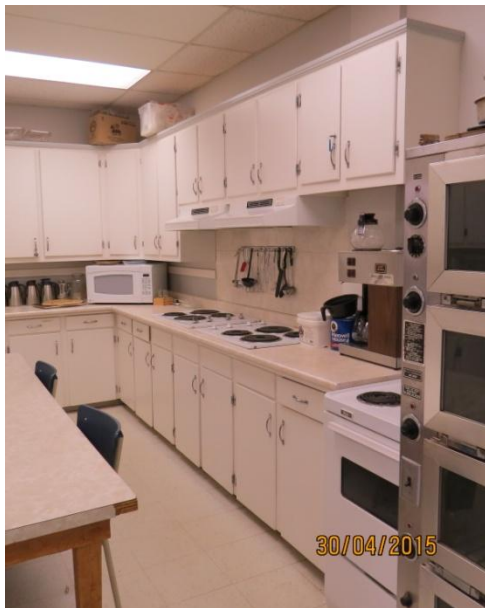
The kitchen is in reasonable condition but is missing key equipment to meet current codes and standards. An exhaust system is required for the commercial ovens, a CO and smoke detection system is required, wood and flammable products cannot be placed or stored in close proximity to ovens or other cooking appliances. The large commercial ovens should be certified to ensure there is no leakage or areas of concern considering the age of the equipment.

Wood and flammable products need to be relocated

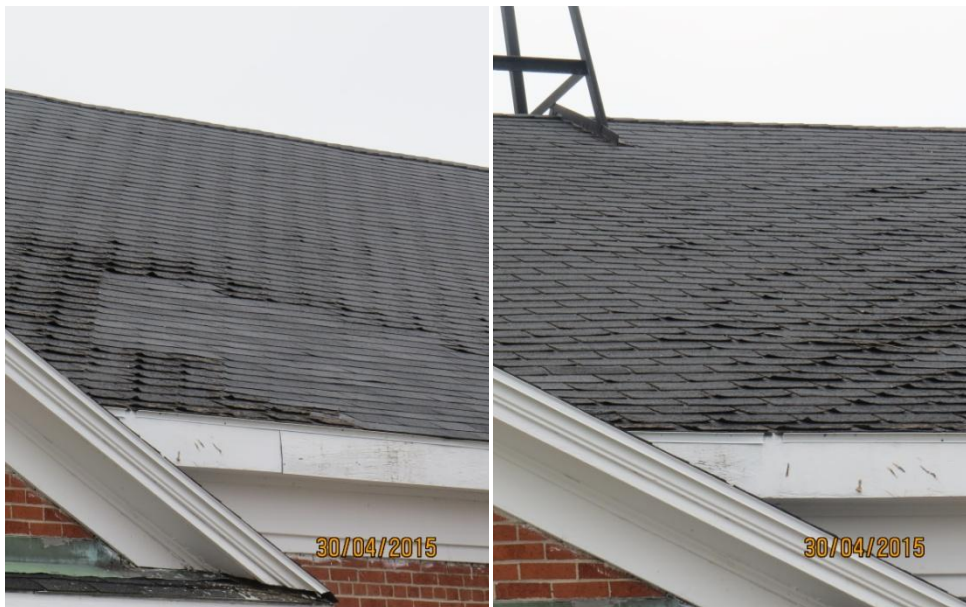
The shingled roof system is in poor condition with several areas of damaged and missing roof shingles, poor soffit and ridge ventilation and has generally reached the age of replacement.

Typical roof condition- shingles failing

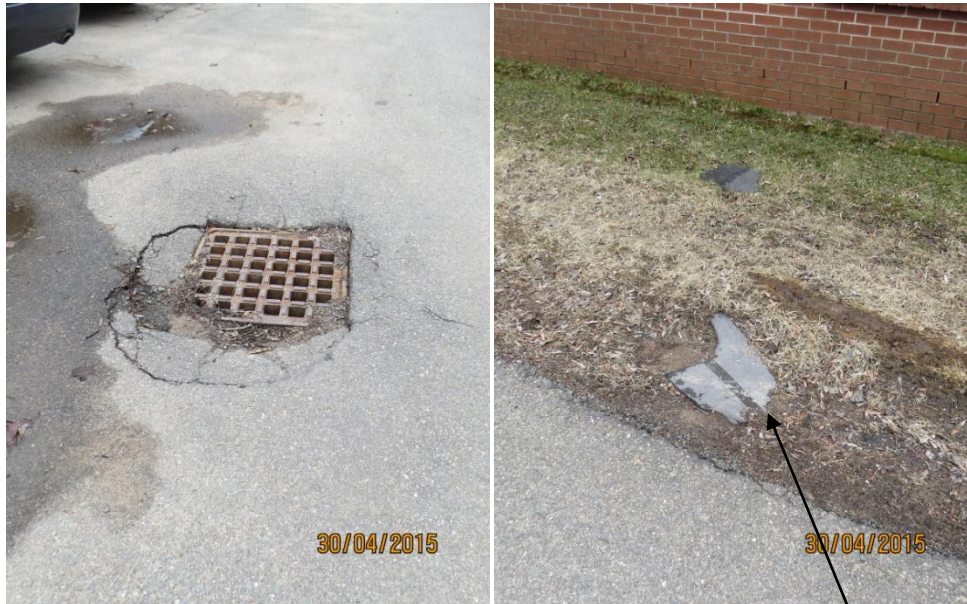
The asphalt surface along the east side parking requires repairs and the catch basin needs to be raised and repaired. The grass areas have been damaged during snow clearing efforts, the wood fence requires minor repairs along the east and south elevations.

Catch basin requires repair

damaged landscaping- note shingles on ground

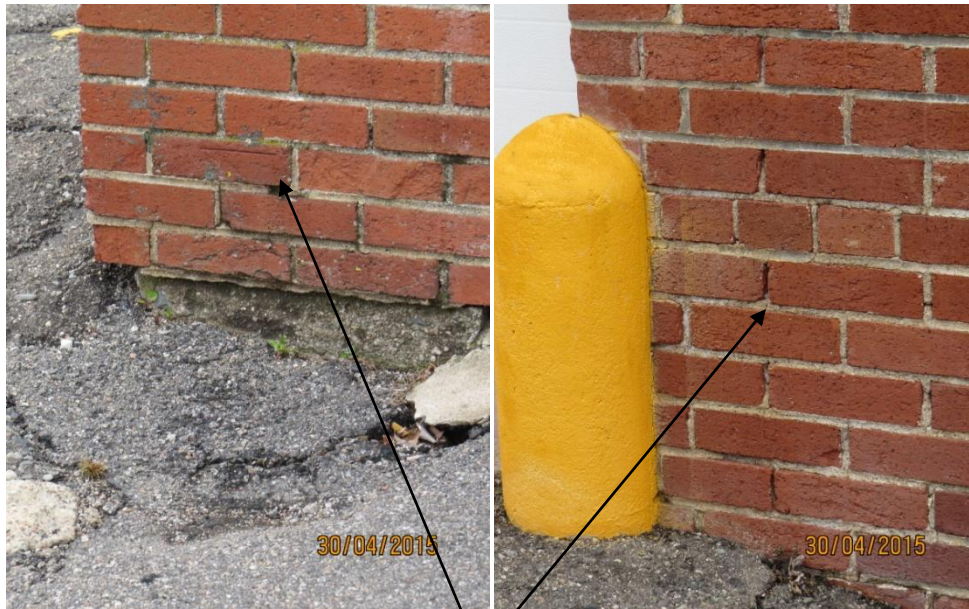
The property contains numerous cracks and deflections which need repairs to sustain this property. Constant cracks will permit water entry, ice to form and expand, creating additional damages and concerns. Most of the exterior cracks follow the brick/masonry mortar lines and are considered deflections non structural, those cracks which split bricks/masonry are structural deflection/settling and more concerning. The photos attached are examples of brick and mortar decay and structural deflection, 37 locations noted during our review.

Mortar and brick decay- non structural

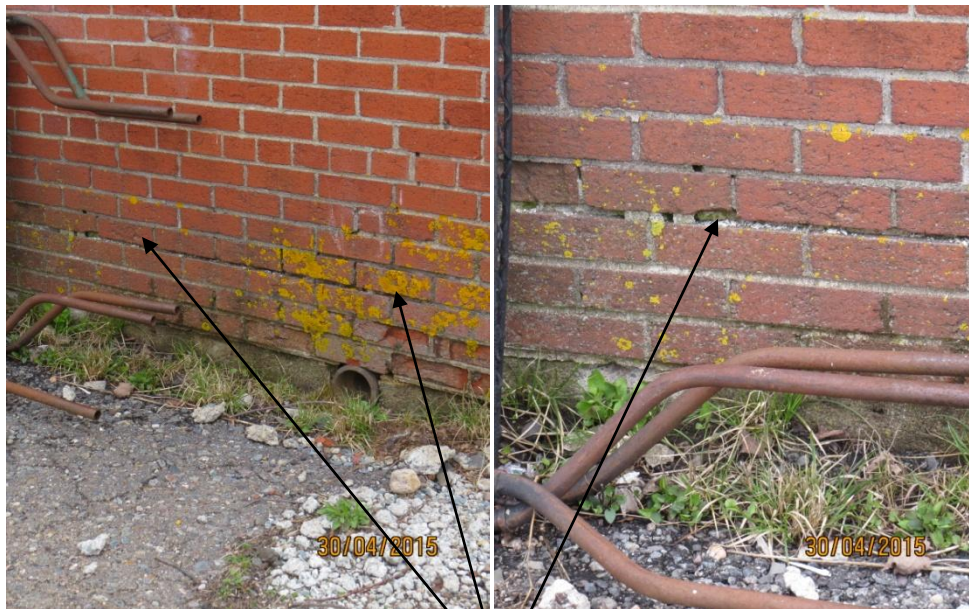
Mortar and brick decay- non structural

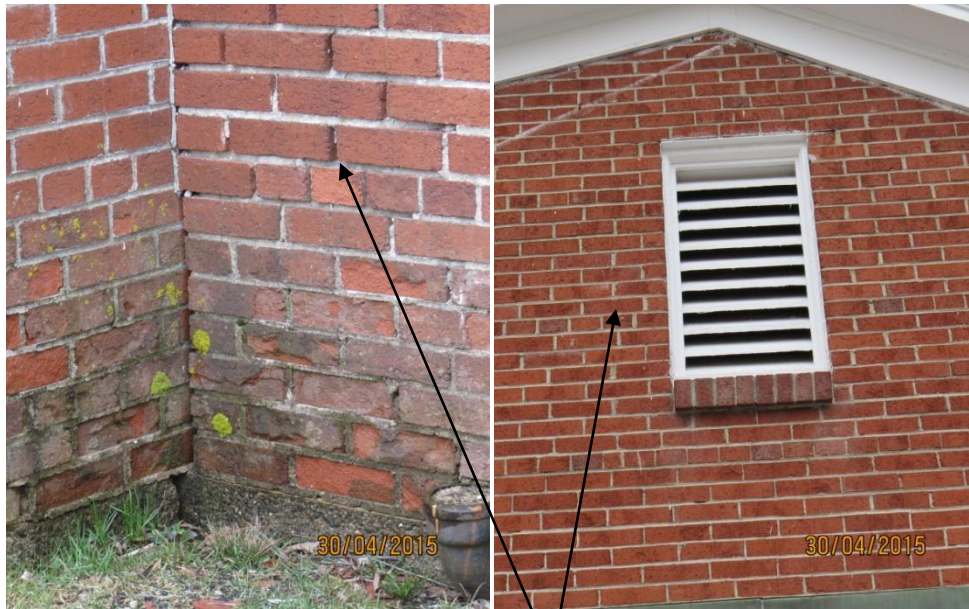
Mortar and brick decay- structural deflection

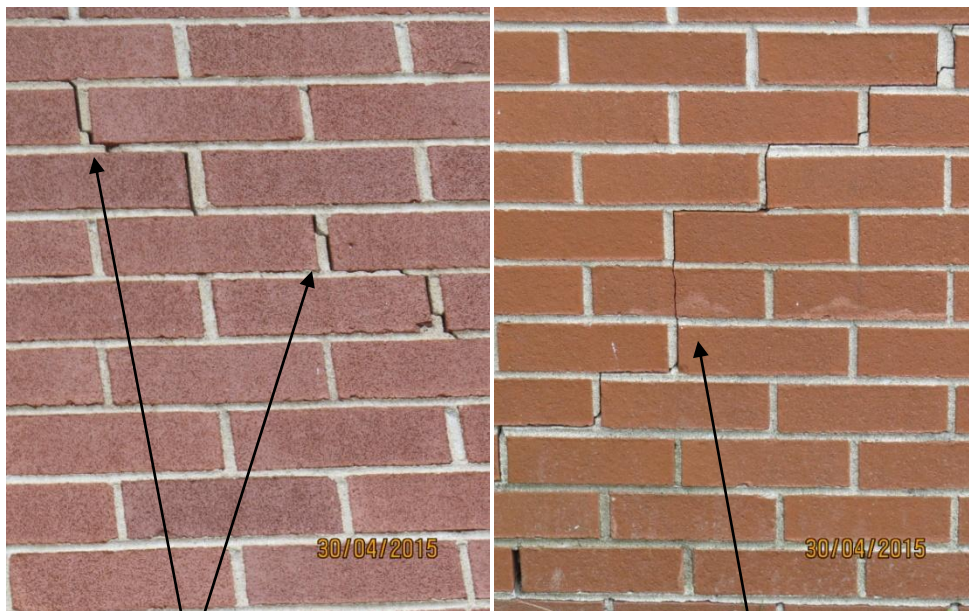
Mortar decay

structural deflection

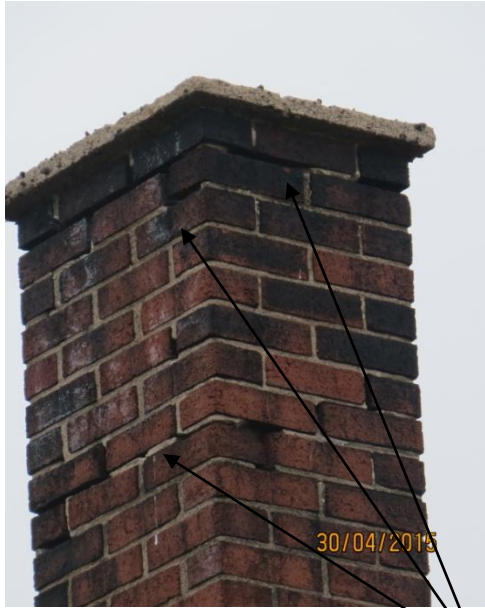
Structural deflection and mortar decay

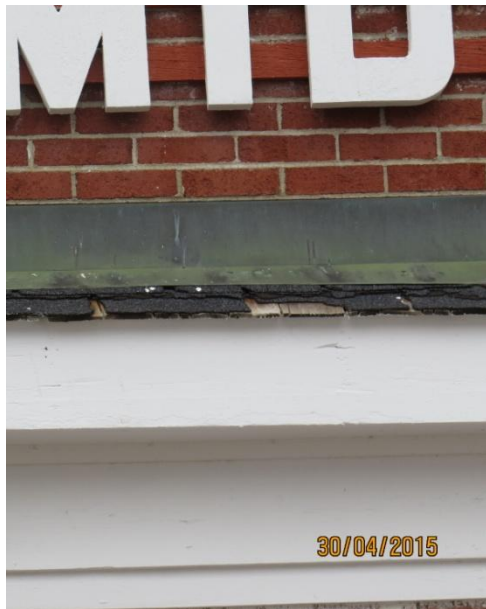
Flashing and shingle failure above vehicle door

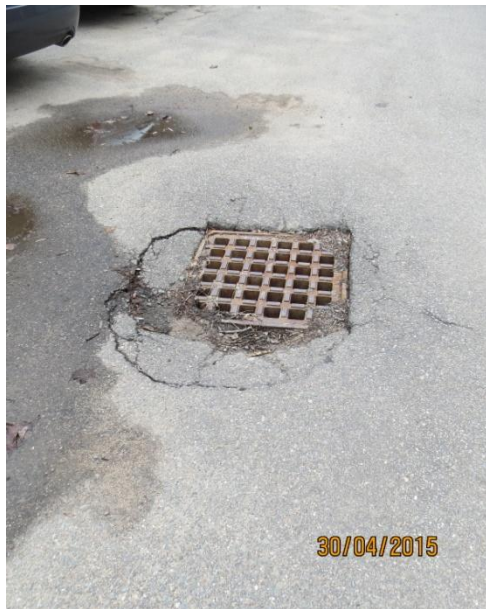
The west asphalt area is shared with the Town Hall and is in poor condition (noted in Town Hall assessment). The north vehicle entry asphalt is fair to poor, the east side driveway is in good condition with minor repairs and the south end driveway is in good repair. The catch basin on the east driveway near the parking lot requires repairs.

East side catch basin needs repairs

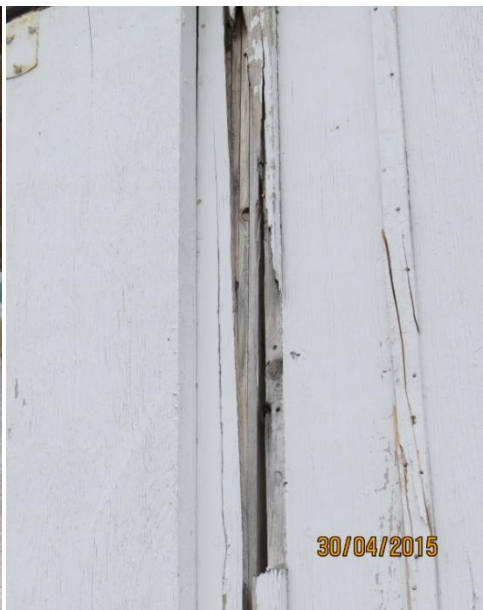
repairs required at doors

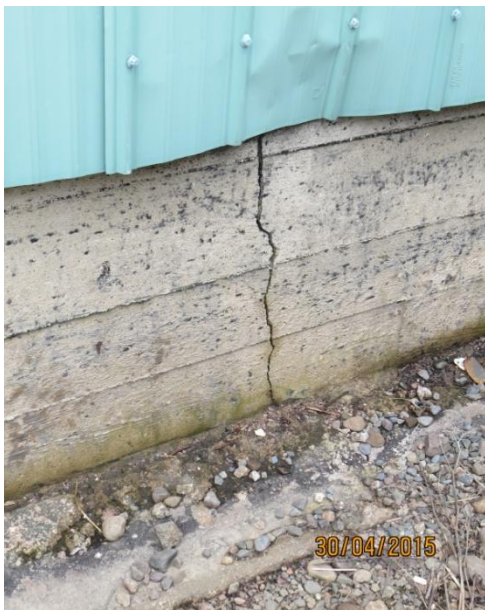
Foundation crack- 4 found

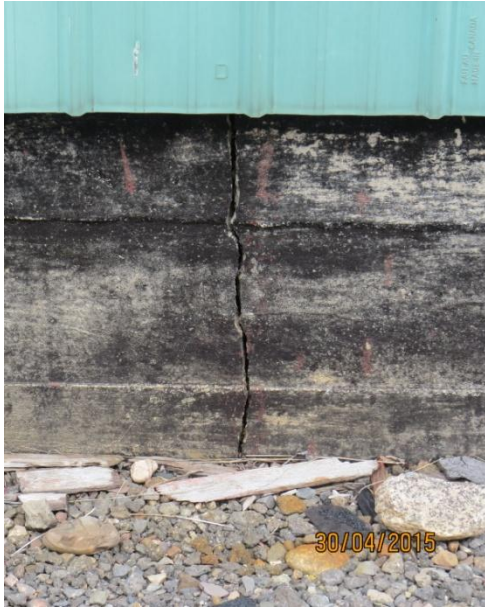
Foundation crack

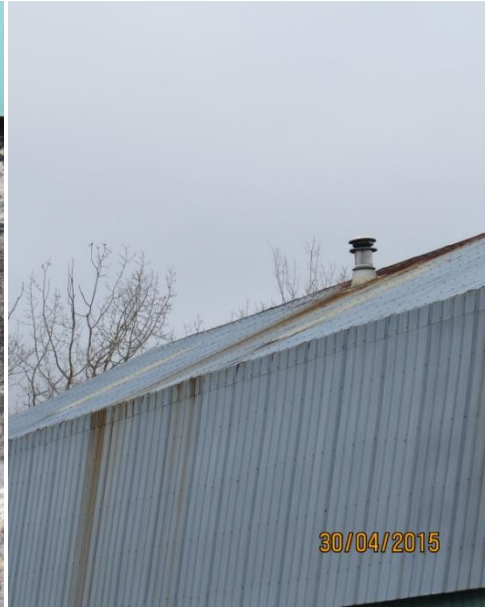
rusting metal roof

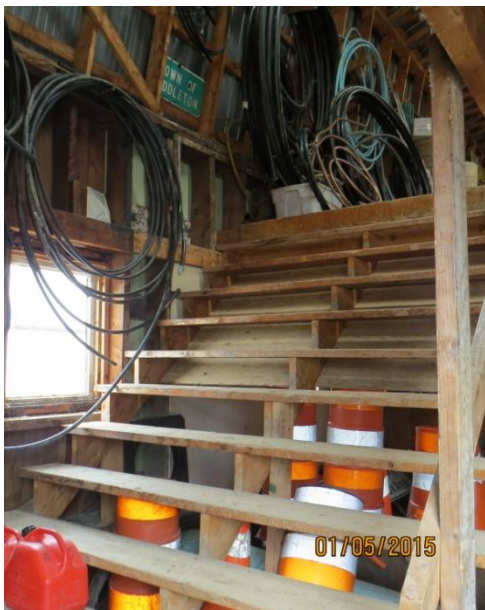
Stairs not to code

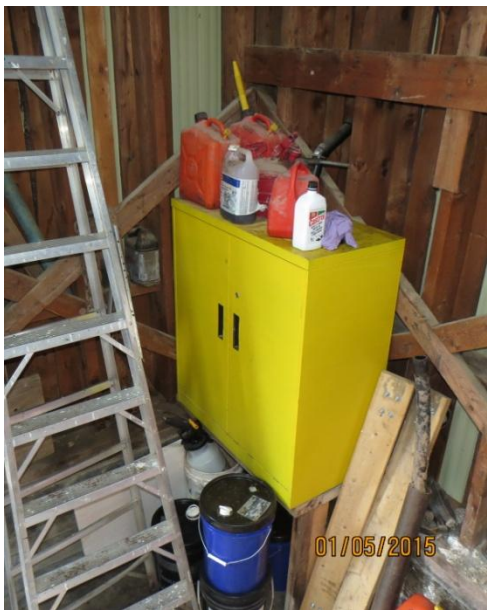
Improperly stored gas and oil cans

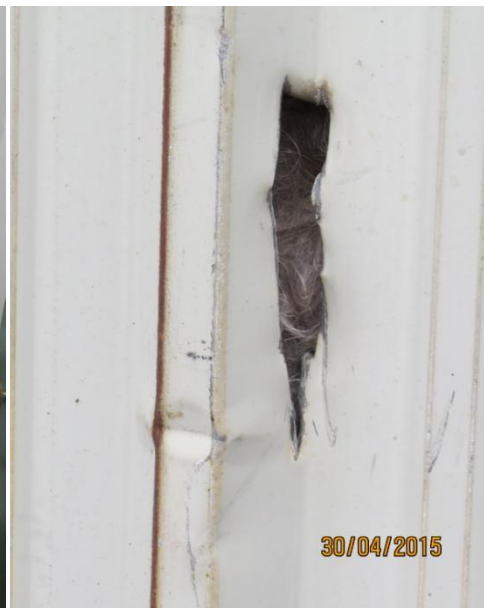
Damage to exterior wall

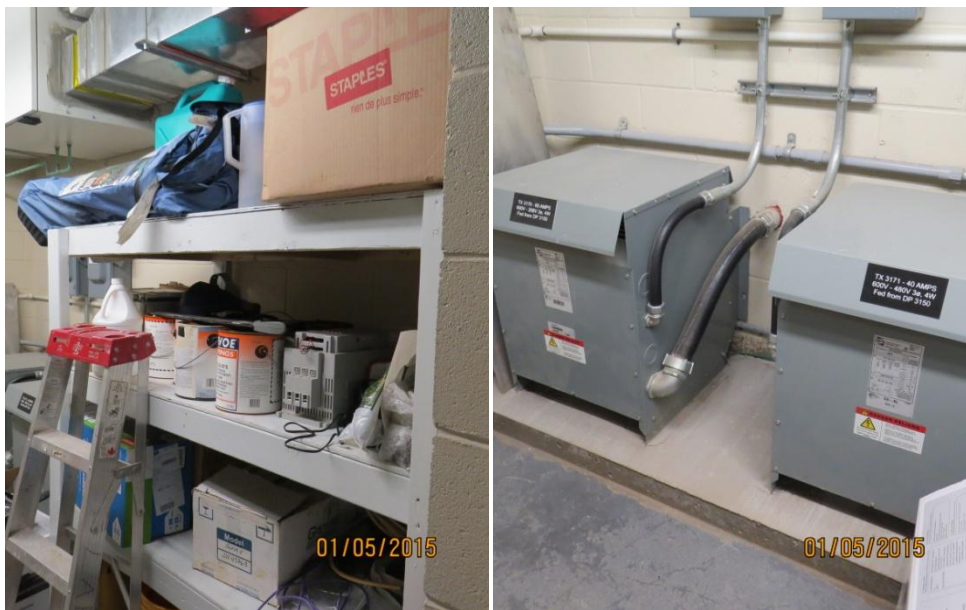
The main electrical room is 347/600v/3ph/400 amp Square D c/w a PJ400 Power-pact switch interconnected with a Kohler generator (model SD2S-610 fuel fired/operated). Transformers for the electrical service were placed in an adjacent room which is now being used for storage of miscellaneous products. The National Building, Fire and Electrical codes do not permit non electrical products to be stored in electrical rooms.

In transformer room- Code violation

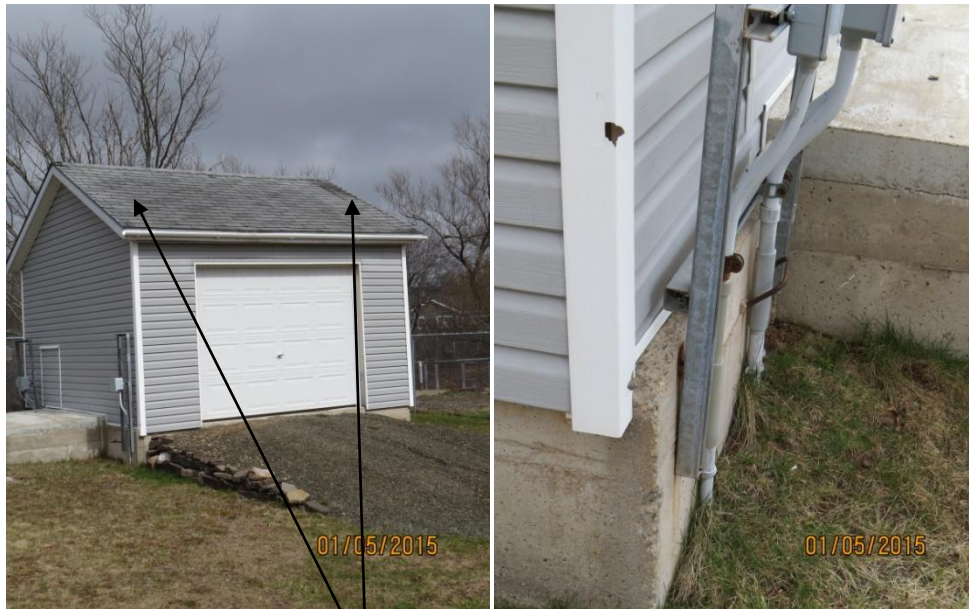
Small grey coloured vinyl sided building located near the main sewage collection chamber measuring approximately 12' x 12' in size. The roofing system is in poor condition and needs replacement. The electrical system originally attached to the structure needs to be secured.

Asphalt shingle system failure

attach/secure electrical system to structure

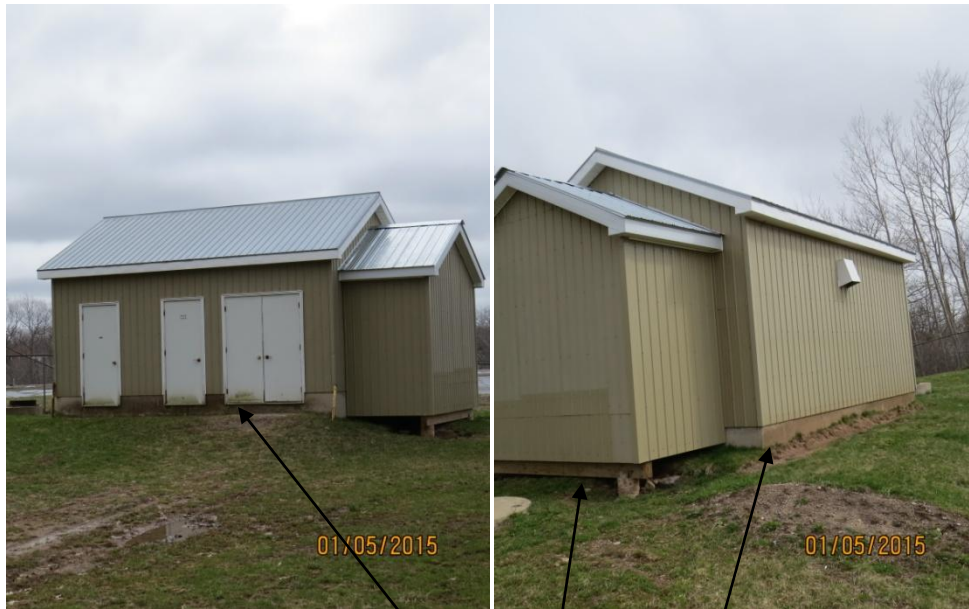
The main entry door requires minor maintenance, the roofing system appears good (metal an no signs of leaks), the exterior of the structure appears to be in good condition.

Minor maintenance at front doors

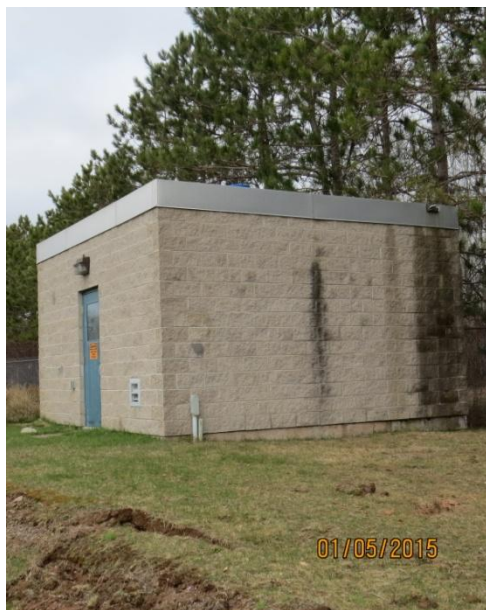
The masonry is in poor condition and requires re-pointing of the block work. The roofing system is failing and contains two small leaks today. There is strong evidence of major roof failure in the near future due to tar based products being released from the roof and running down the side of the masonry block in 3 locations. These heavy black tar filled drainage marks (evident in the photo above) are very good indicators of roof system, delaminating being washed away by natural rain fall events.

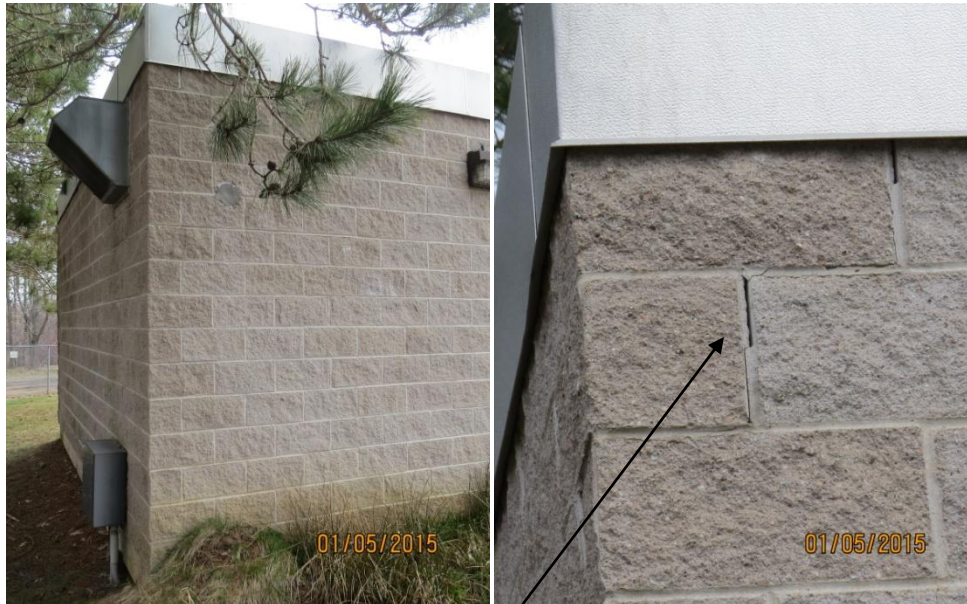
Masonry joint failures- several locations

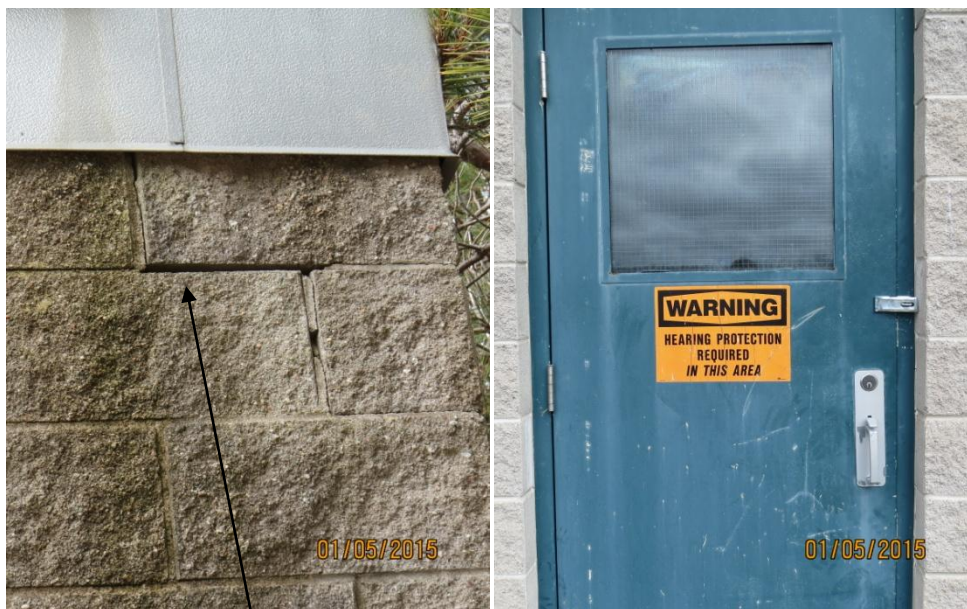
Masonry joint failure

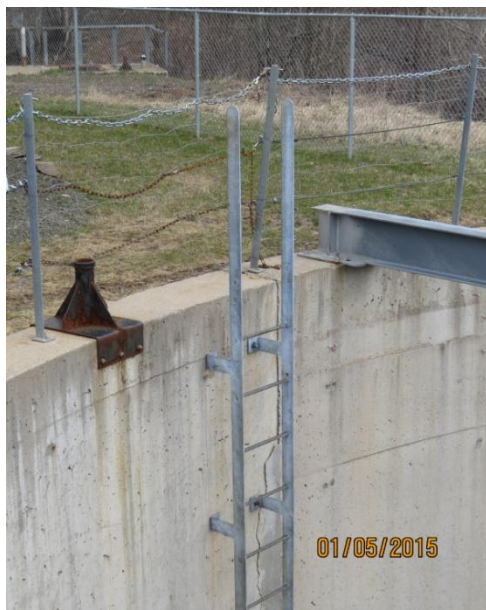
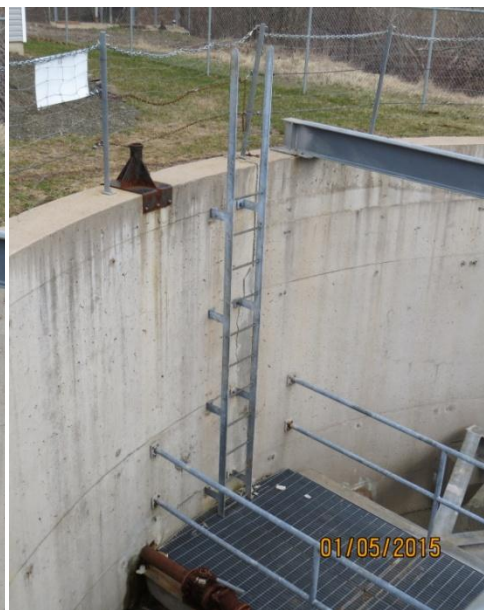
During our review we noted an observation which should be addressed on the main sewage collection chamber. The access ladder system, in accordance with NS OH&S Act shall extend a minimum 3 feet above a flat surface, shall be fully enclosed for any elevation over 8 feet and shall contain a flat platform at both the top and bottom for safe entry and exit. This ladder system does not comply with Provincial Act.

Ladder system to be modified to meet NS OH&S

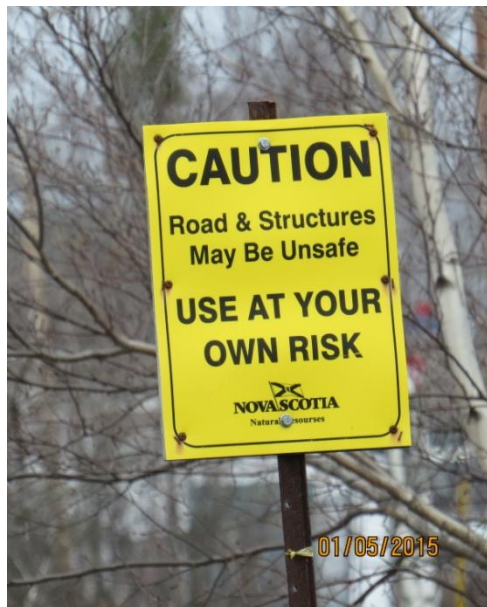
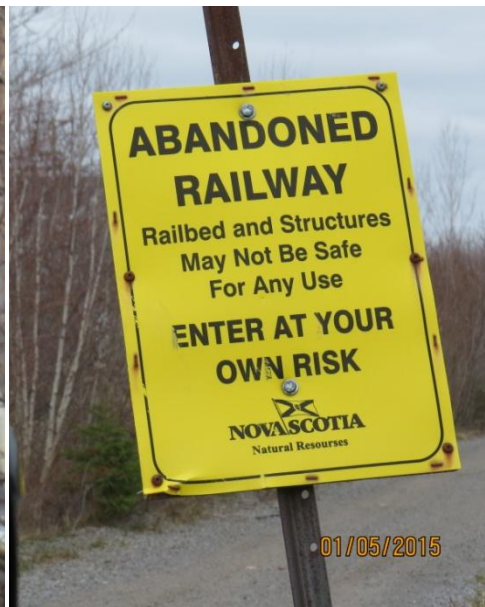
Typical signs found- additional signs required

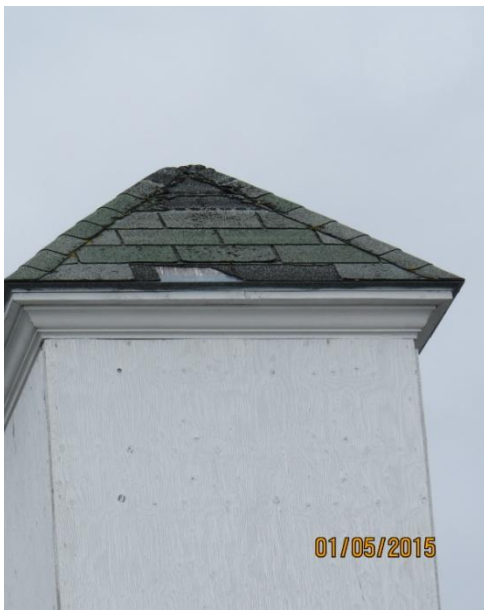
Tower on roof- shingles missing

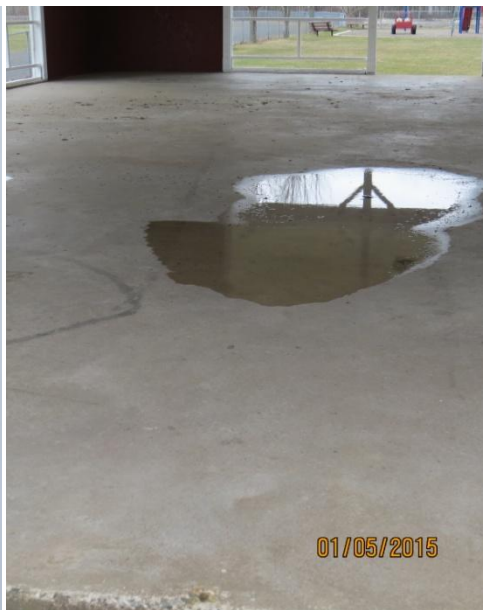
concrete floor cracks and water pond

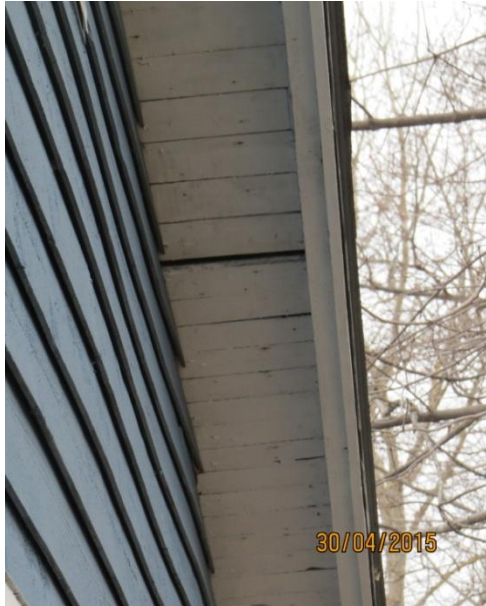
There are small areas of concern which should be address which include the main entry wood door and wood frame has decayed, the wood soffit requires minor repairs, the concrete blocks supporting the structure have shifted. The flag pole system requires repairs and painting, the pole is slightly tilted.

Minor repairs to wood soffit required

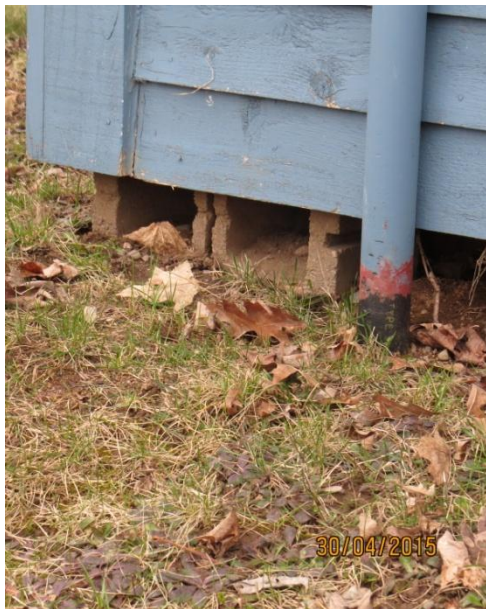
Concrete block footings have shifted

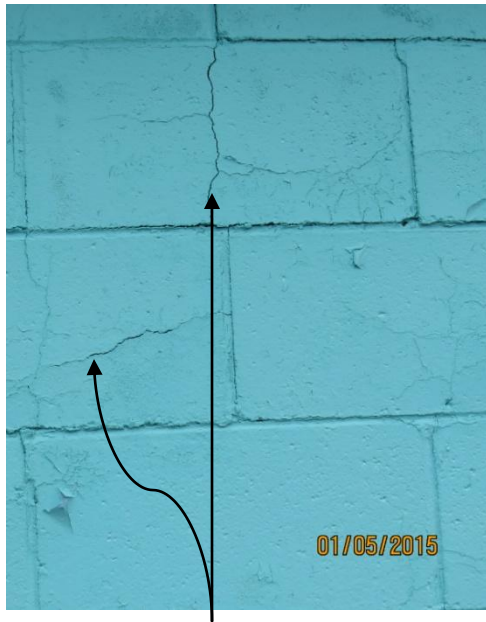
1. The **building structural assessment is a priority 1** because of the extensive amount of structural cracks. Seam cracks, between concrete blocks are fairly common, structural cracks are those which extend across and through the physical blocks. 30+ structural cracks were noted.
2. The leaking roof is causing extensive decay to the wood framing supporting the roofing structure above. Constant leaks will decay the wood support structure and potentially cause total roof failure.
3. Costing noted does not include repairs to the concrete block building structure. The structural assessment is required before investing in repairs. The structural assessment may require additional works to be completed prior to physical block repairs.

Structural crack

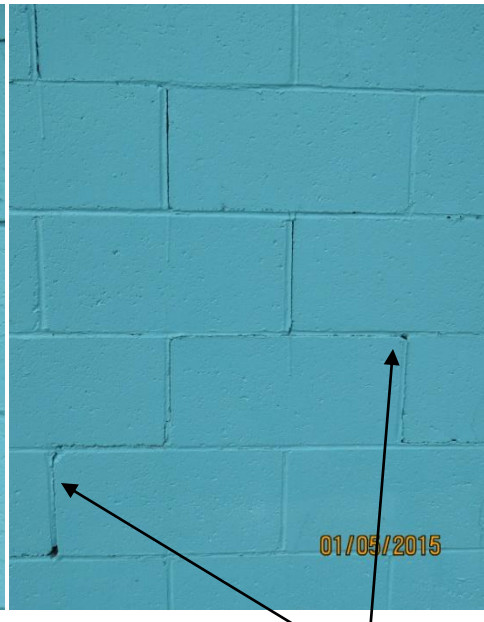
non structural cracks

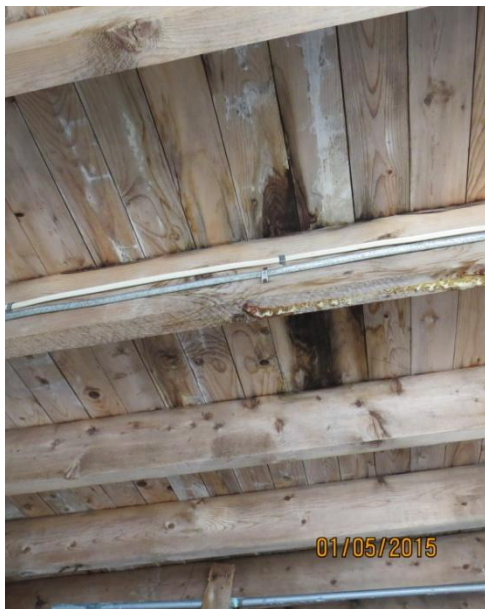
Leaking roof
