Town of Middleton

Facility Assessment and Capital Planning- Final submission

Eagle Project Management Inc.

Facilities Assessment and Capital Planning

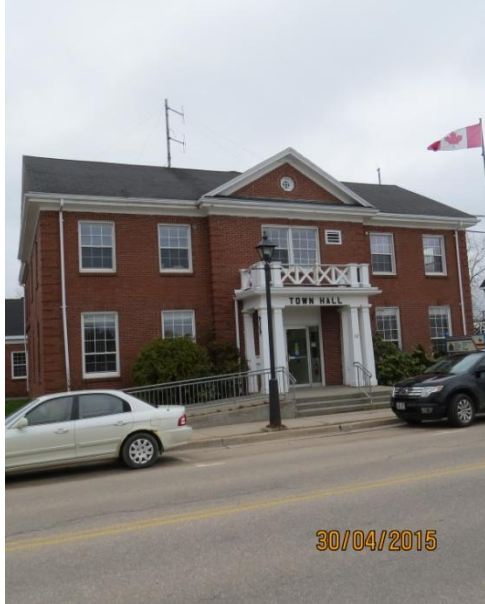
1.1 existing shingles are in poor condition and need replacement

Typical roof condition
Estimated cost: \$ 14-16,000

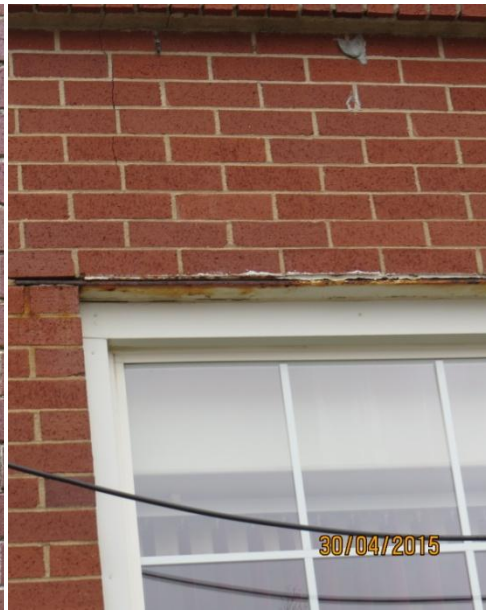
East side

2.1 The walls are constructed of a mixture of brick and concrete materials with minor cracks and deflections.

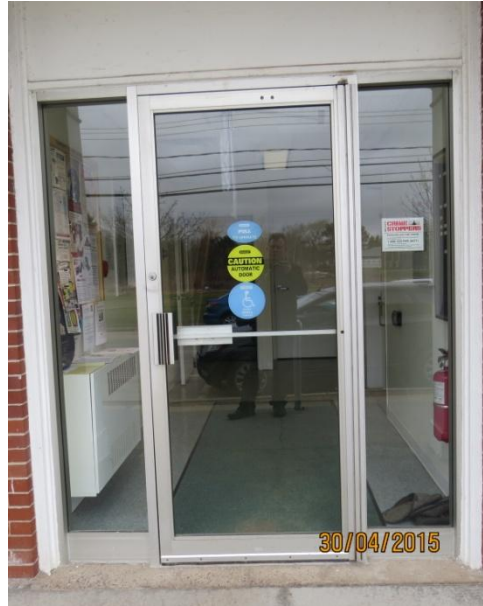
Main front entry

3.1 Generally in fair to good condition

3.1.1 Replace damaged and worn door seals, threshold sweeps, and casing and door frame sealants.

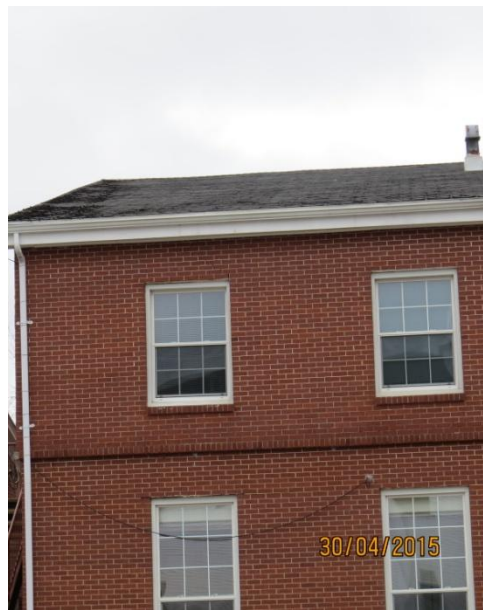
Typical windows

Estimated cost to repair: \$ 2,500

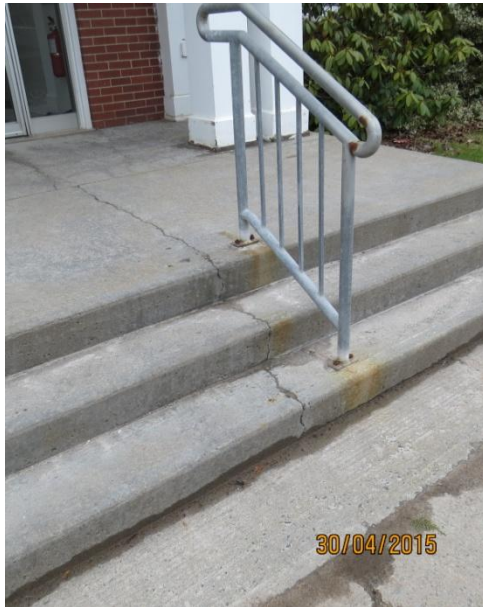
Handrails not to NBC code

Estimated cost \$ 1,500.00

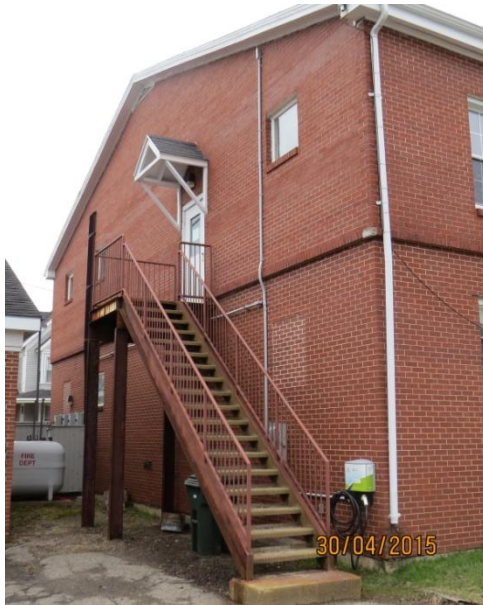
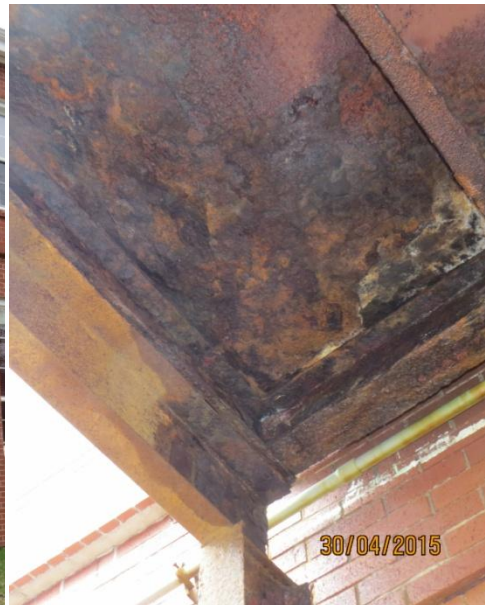
5.1 This structural steel system requires immediate attention. The steel has decayed aggressively in two key areas, the mounting of the top platform and the vertical connections to the support members. This is a mandatory Building Code requirement for a property of this size and usage therefore immediate repair for life safety needs to be considered. Replace the damaged structural steel.

Structural decay extensive- needs repairs/replacement

Estimated cost to repair option A: temporary repairs \$ 2,500.00

Estimated cost to replace option B: \$ 18-20,000 (does not include foundations- presumed reuse)

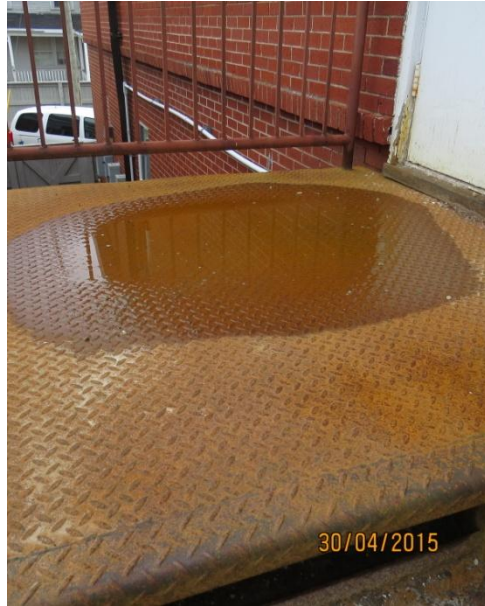
Top of fire exit stair/platform system

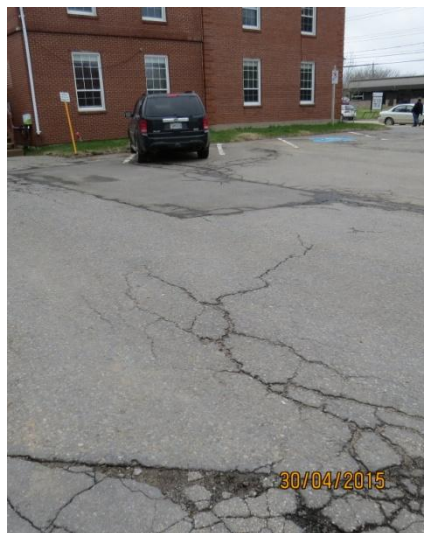
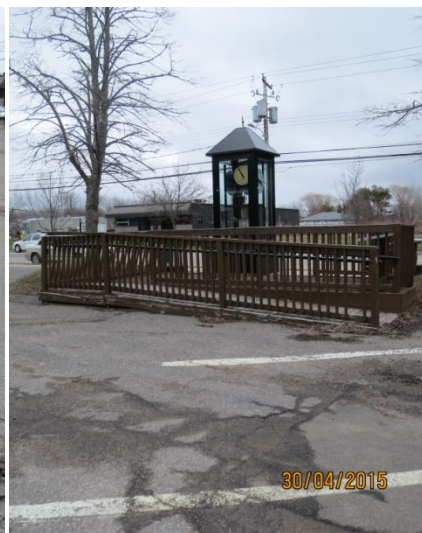
6.1 The asphalt parking areas have been patched on several occasions and are showing signs of great decay. Remove asphalt, excavate to minus 18", remove soft- unstable fill, install class D (3"-4") compacted gravels, place, 4" thick class A highway mix gravel compacted, install new highway mix type A asphalt.

Typical asphalt condition

6.1.1 Patch and repair only \$ 2,500.00

6.1.2 Replace \$ 38,600.00 (does not include RCMP side)

6.1.3 RCMP- repairs \$ 800.00

6.1.4 RCMP- replace \$ 4,500.00

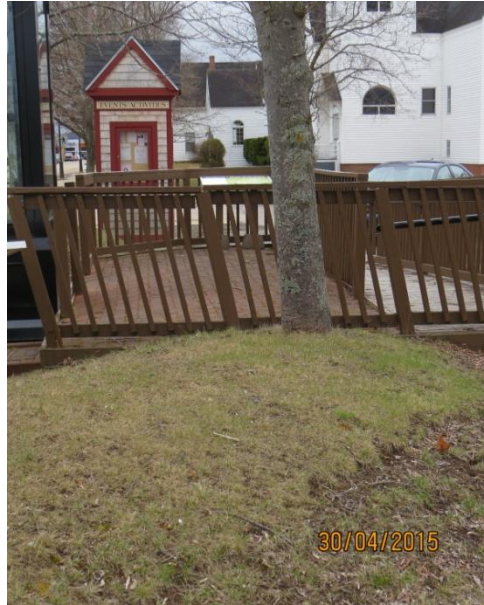
7.1 Damaged fencing

- 7.1.1 Repair wood fencing- RCMP side and accessible ramp system to bus stop at Northwest corner of parking lot
- 7.1.2 Repair misc grass areas damaged during winter snow removals and general vehicle traffic

Estimated cost to repair: \$ 1,500.00

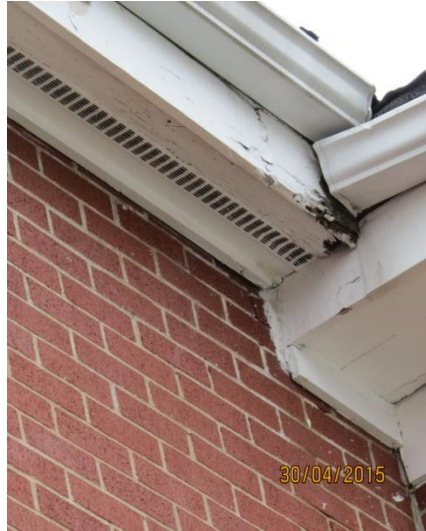
- 7.2.1 Wood structures require painting. Front elevation columns and decorative works do not contain moisture relief drainage causing paint to prematurely flake off the wood products. Ensure moisture release holes are installed, scrap, clean and prime all areas with alkaline based paints. Previous paint products may contain lead based products- latex paints will not bond properly to lead based products.

Wood structure requires painting

Estimated cost to repair, misc exterior works; \$ 5,500.00

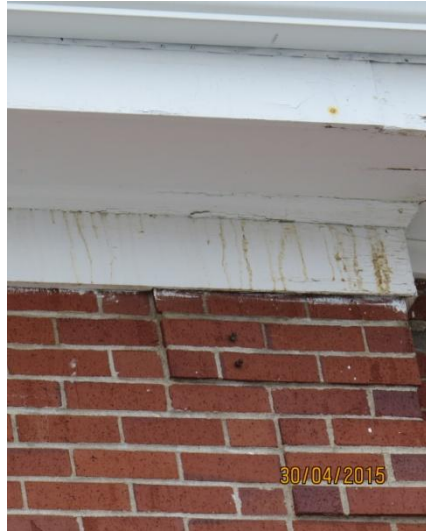
8.1.3 The wood fascia boards need minor repairs and painting

Asphalt leakage behind fascia- roof replacement required- see main building details

Estimated cost to repair, replace 2 doors, repair masonry, painting and finishing,
\$ 10,500.00

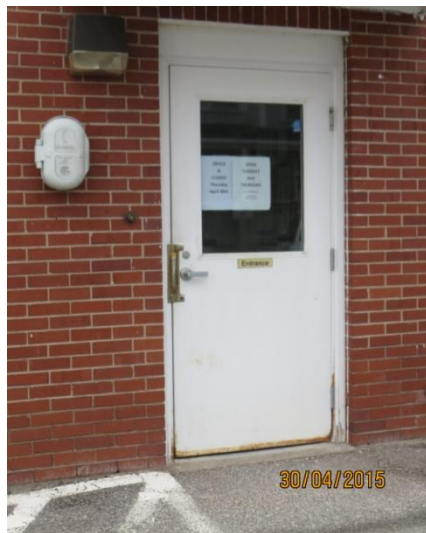
8.1.1 The RCMP public entrance door requires extensive repairs. The steel door and frame have decayed and the door “jams” when in use.

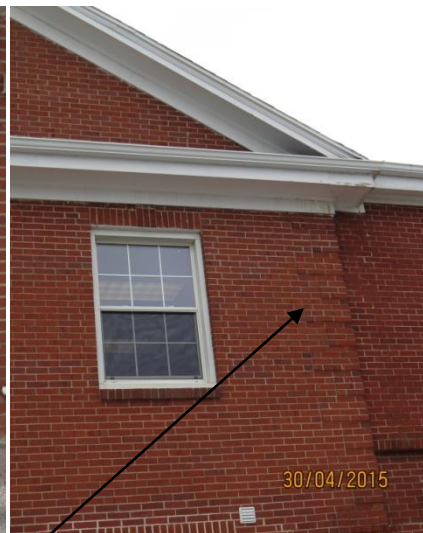
8.1.4 The masonry requires minor repairs

Southeast corner- masonry repairs

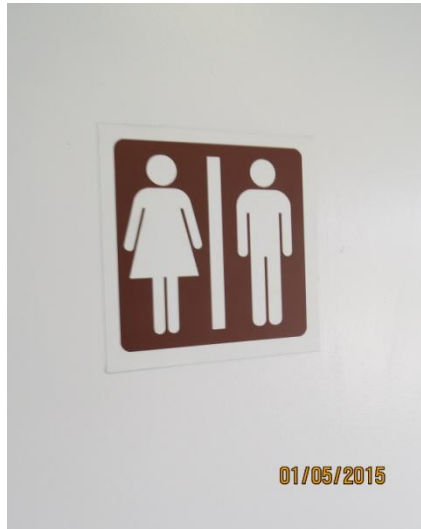
- 9.2.1 The washroom meets the NBC intent. Consideration should be given for the installation of an audible alarm system considering Town staffs are not likely to notice a person in distress within the washroom.

Unisex signage

Estimated cost to repair \$ 2,200.00

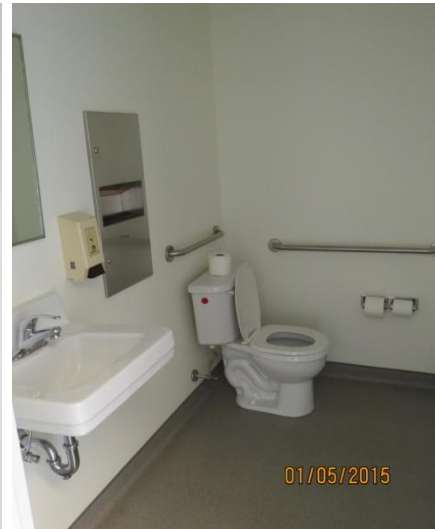
unisex washroom

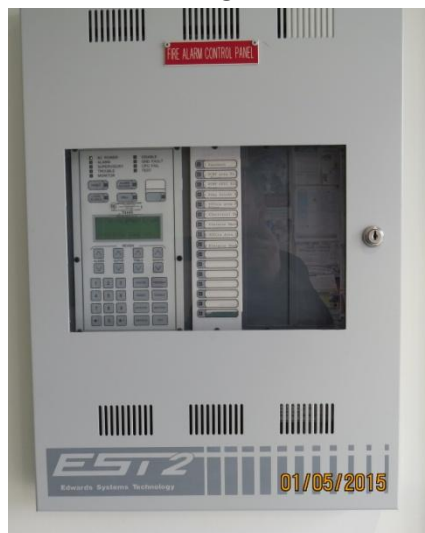
Located at main entry foyer

- 10.1 The property does contain a fire alarm system which was operational during this review. Annual certification and testing documents also noted.

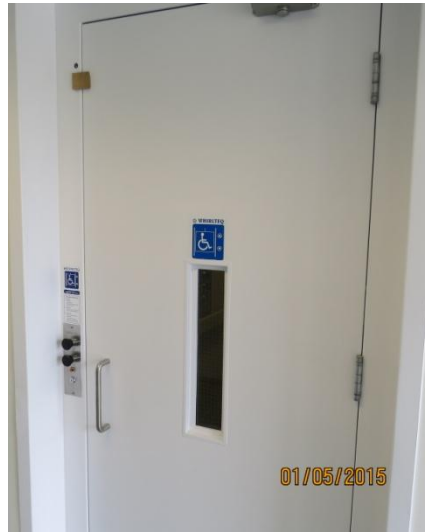
Located at main entry foyer

- 10.2 The building does not contain a generator or emergency power systems. A person could be trapped during a fire egress situation.

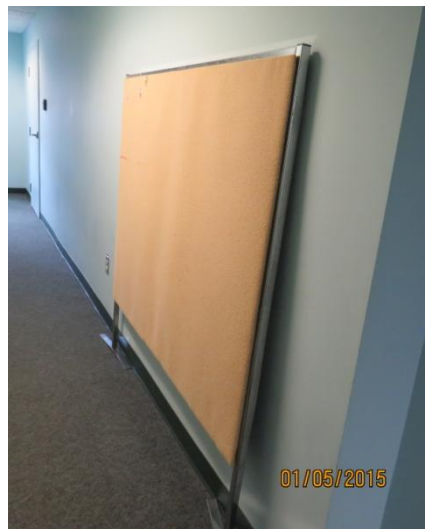
- 10.3 The building is primarily wood construction with brick exterior. There is no fire separation between the floors, the stair and exit system are not fire rated, between the floor and between adjoining rooms are not fire sealed, between the upper floor main hallway means of egress and the upper floor egress door are not fire rated or sealed. The upper floor means of egress is partly blocked with a moveable office partition which may cause blockage during a fire escape- removal required. The upper floor contains two ceiling elevations, the exposed lower suspended ceiling and the original pressed tile upper ceiling. The upper ceiling contains several areas of historic water leaks. The upper ceiling areas should be checked for mold and asbestos products considering the age and condition.

Remove products from hall

Estimated cost to repair \$ 165,000

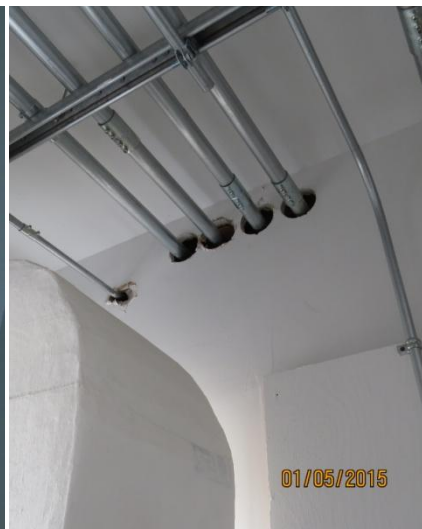
electrical pipes not sealed

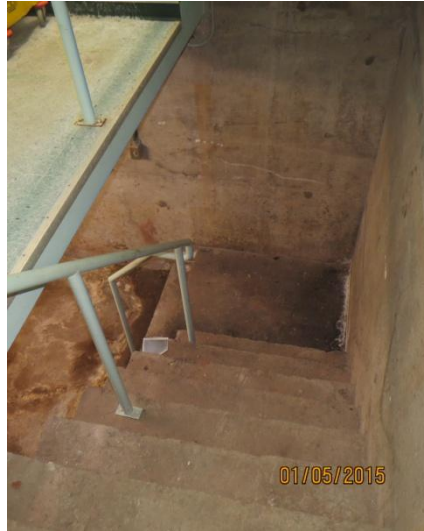
Handrails not to NBC

- 11.2 The stairs leading down are fair at best, the handrails do not meet NBC; the basement concrete floor surfaces are wet and could cause hazards from electrical shock or general slips and falls.
- 11.3 The floor tile, vinyl acoustic tile (VAT) of 12`` size with notable black adhesive. The adhesive materials, depending on actual age, have been known to contain asbestos. Estimated cost to repair, add wall insulation, add ventilation, seal and repair floor, repair handrail systems \$ 7,500.00
- 12.0 Upper and lower floor office space areas
 - 12.1 Primarily carpet flooring and vinyl flooring
 - 12.1.1 Room 202 Council Chambers- water stain on suspended ceiling
 - 12.1.2 209B water stain on suspended ceiling
 - 12.1.3 Carpet floor in fair condition
 - 12.1.4 Vinyl flooring in fair to good condition
 - 12.1.5 Baseboards and trims in good condition

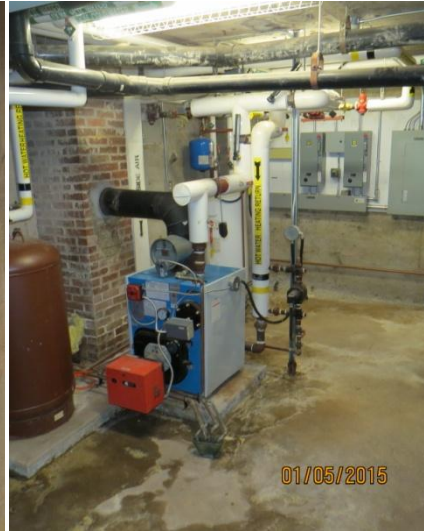
11.1 This area contains the main heating and water systems and is not occupied. Access is via the main foyer door adjacent to the accessible washroom. The basement is very damp and contains no insulation or ventilation systems.

wet concrete floors

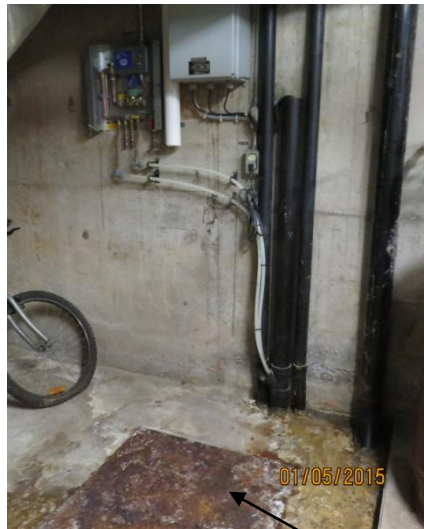
Decayed cover on sump pit

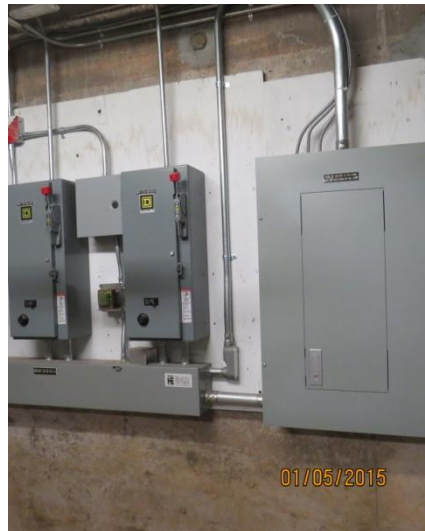
Secondary system-basement

13.1 The property contains 1 primary system and 2 secondary distribution systems. The primary 1200 amp, fused at 400, 3ph, 600 volt is located on the upper floor main electrical room. The basement contains distribution for mechanical system (boiler and hot water) and the upper floor mechanical room contains distribution for the air condition system. All electrical systems appear to be in good condition, the panels are labelled, doors secured.

Estimated cost to repair \$ 1,000 annual cleaning and inspection of breakers and equipment

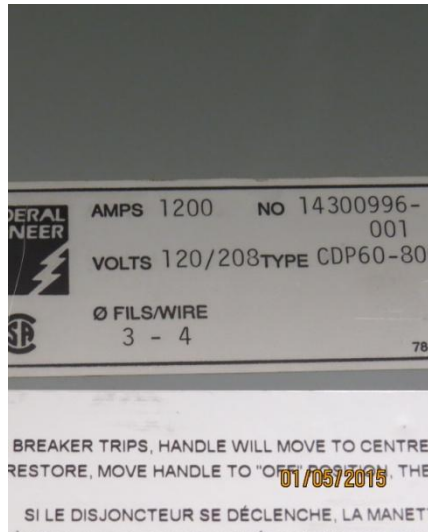
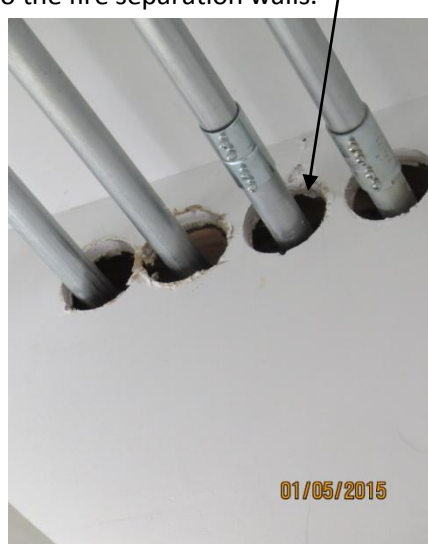
- 13.2 The electrical piping system extending from the HVAC room to adjacent space areas is not sealed to the fire separation walls.

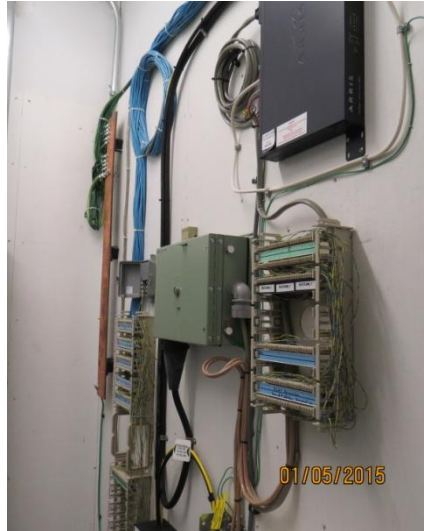
- 13.3 The emergency lights (battery packs) were tested and found in working order.
- 13.4 The fire alarm system and telecommunication systems all appear to be in working order.
- 13.5 Materials, plastic bins were found stored in the main telecommunications room.
- Materials are not permitted to be stored in operational rooms- NSP, NFC codes.

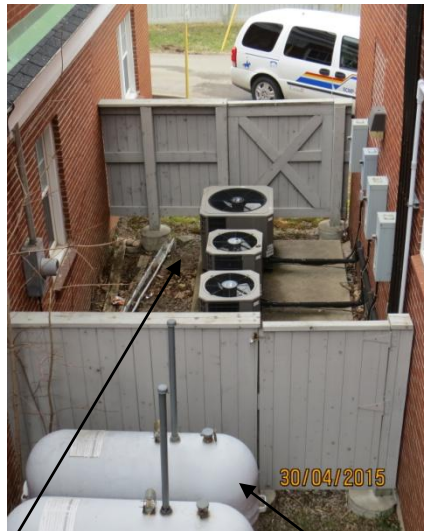
14.1 This property contains two heat pump air condenser cooled systems commonly found in properties of the size and context. Internal distribution is via 2- York (model G+FD036S17A) forced air fan systems located on the upper level mechanical room c/w electronic central controls. The condensers are located on the east elevation at ground level between the Town Hall and Fire hall buildings. The physical condition of the systems appears good, the filters were in fair to good condition, the duct work is sealed (areas that are exposed). Verbal interviews with a 4 random staff indicated summer cooling is a concern but air flows appear good.

Condensers/heat pumps,
Fuel tanks are for fire hall
Estimated cost \$ 125,000

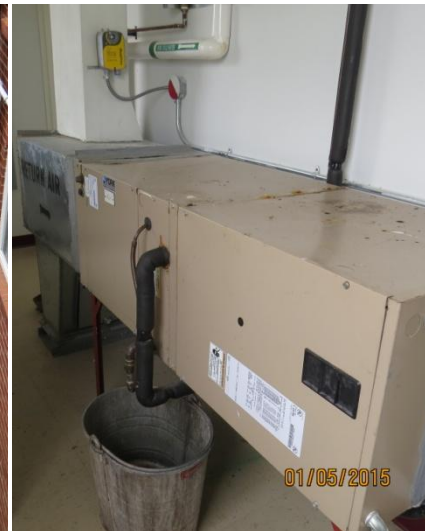
typical interior York distribution

14.2 The physical size of the heat pumps appears to be designed properly for a building of the size and content. However; the building is showing signs of aging, the separation walls

are not sealed and therefore a constant cooling loss is prevalent. Based on observations above the suspended ceiling and the open space areas, it is suspected a loss of 35-40 % efficiency with current conditions. A large volume of air is migrating above the lower suspended ceiling system to the upper void cavity space.

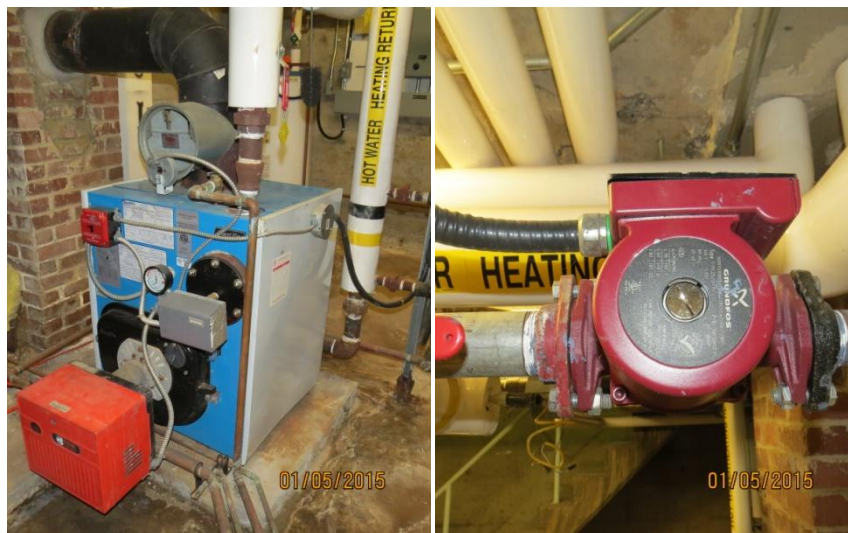
14.3.1 A single boiler heating loop system is located in the basement elevation. It is a Slant-Fin oil fired cast iron boiler 248,000 BTU model # Tr-50-XPT, the circulating pumps are Grunfos and the burner is Riello 40-F10. We were unable to locate an age date stamp.

14.3.2 The piping system is a mix of copper and steel commonly found in commercial buildings. The piping system is primarily insulated.

14.3.3 The system appears to be in good working order.

Slant-Fin boiler and Riello burner

Grunfos pump- typical

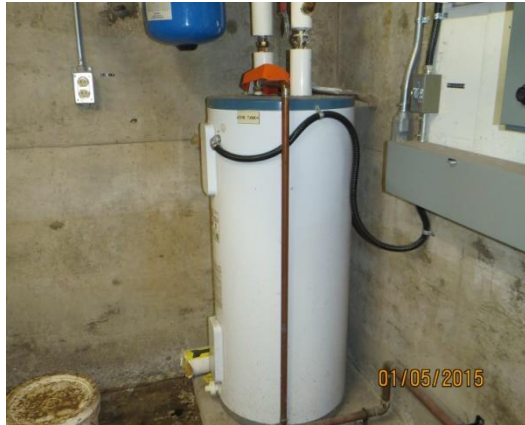
14.4.1 A single 175 liter, 240 volt electric Rheemglass model -RR410T systems appears to be in working order. Age link found on web search to be November 2000. Normal life expectancy 10-12 years. This tank has surpassed normal life expectancy.

Estimated cost including piping \$ 6,500.00

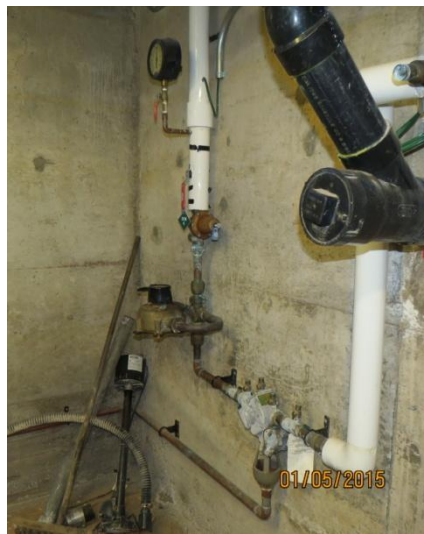
14.5.1 The building does not contain a domestic water backflow system which is governed by the NSOH&S Act, the Municipal Waters Act and the NS DOE. Recommend installing the water backflow system to meet code and operational safety requirements. System should be installed at the main water entry point, basement elevation. Connect the backflow drains to the sump pit for discharge and annual testing.

Main water entry- no backflow system

Estimated cost \$ 8,300

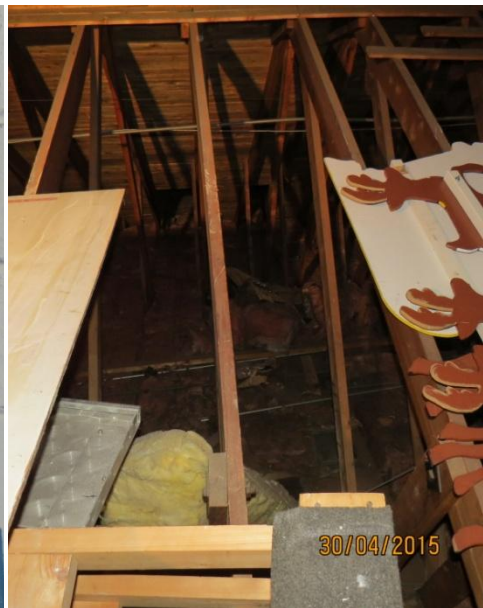
typical attic storage

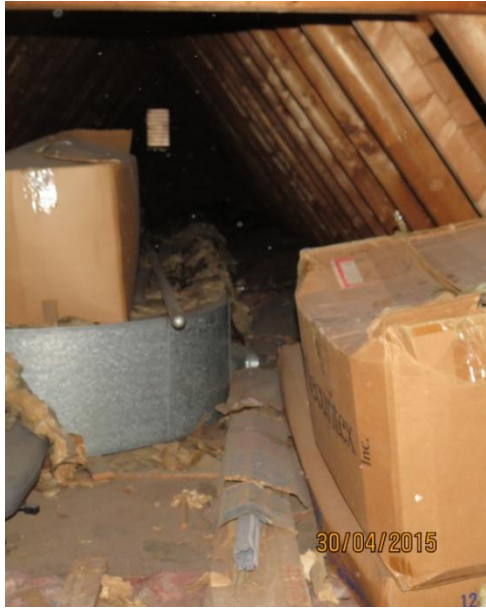
Typical attic storage

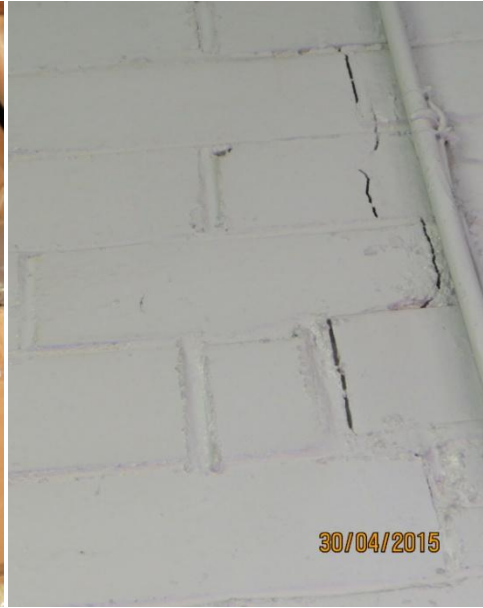
typical structural crack

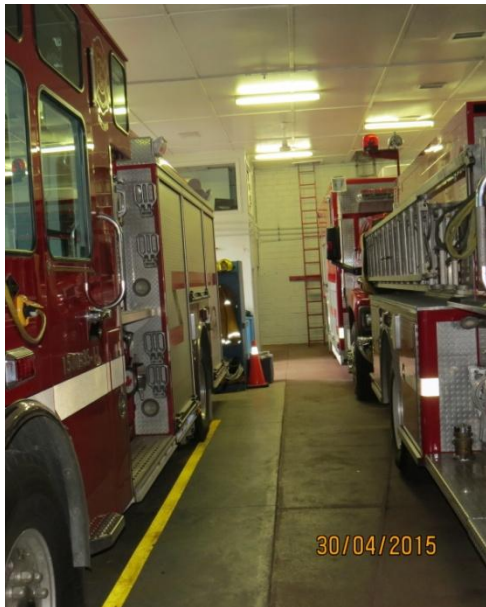
Vehicle bay

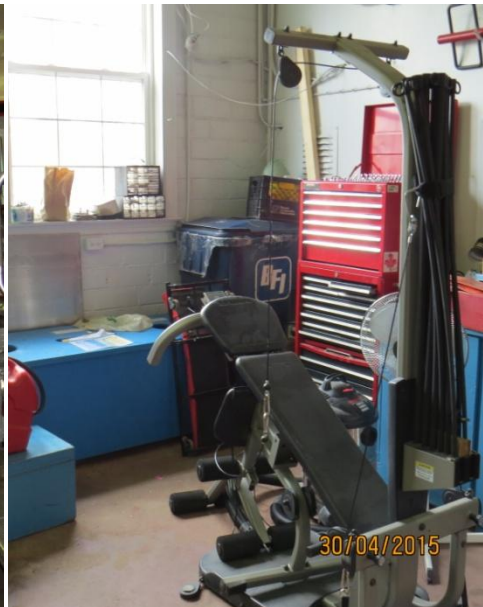
crowded exercise and work shop area

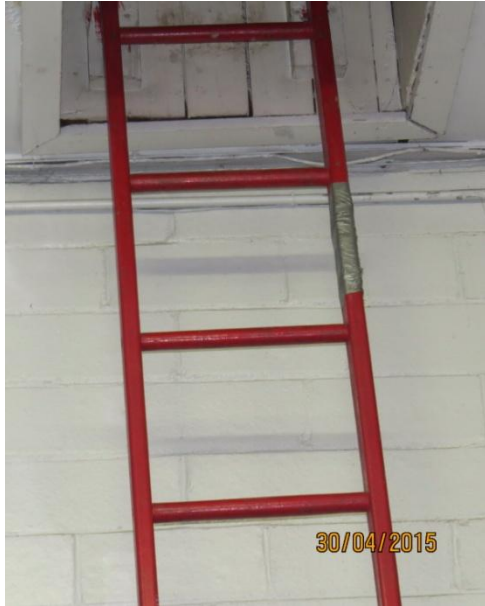
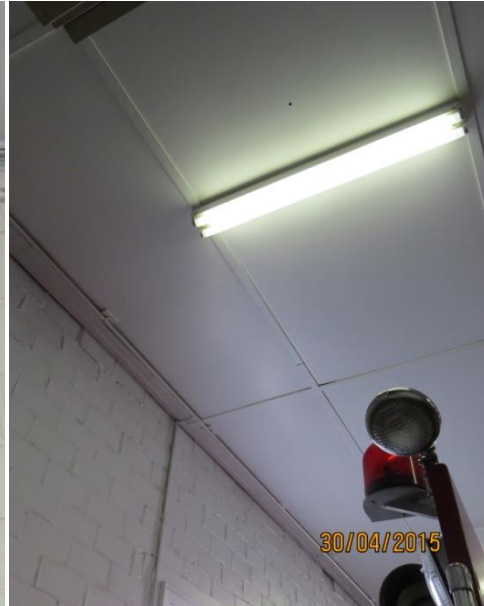
Broken attic access ladder- duct tape on vertical

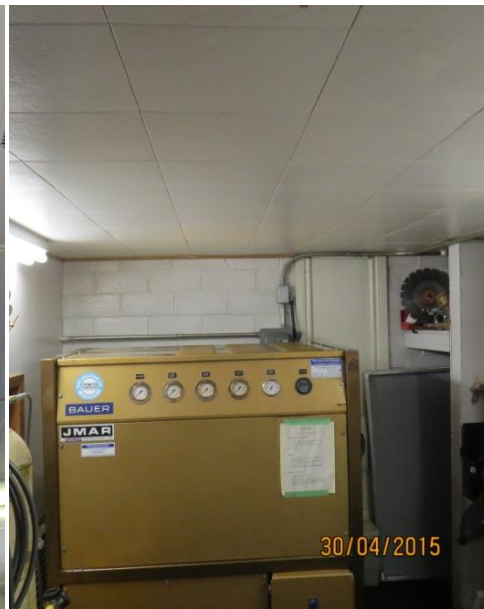
This area contains no exhaust fume ventilation, minimal air circulation. There are low levels of lighting, no interconnected CO exhaust system, is over crowded with emergency vehicles and equipment and is undersized for the Town operations. There are several cracks in the masonry walls, the attic storage access ladder is broken and unusable, equipment storage is very crowded and the small employee exercise room is combined with the tools and maintenance area. The upper radio room head room clearance is poor, the hand railing does not meet code, the physical ceiling height is not to code and the room itself is not fire rated. The breathing air room contains a very low ceiling and it is not fire rated.

breathing air room

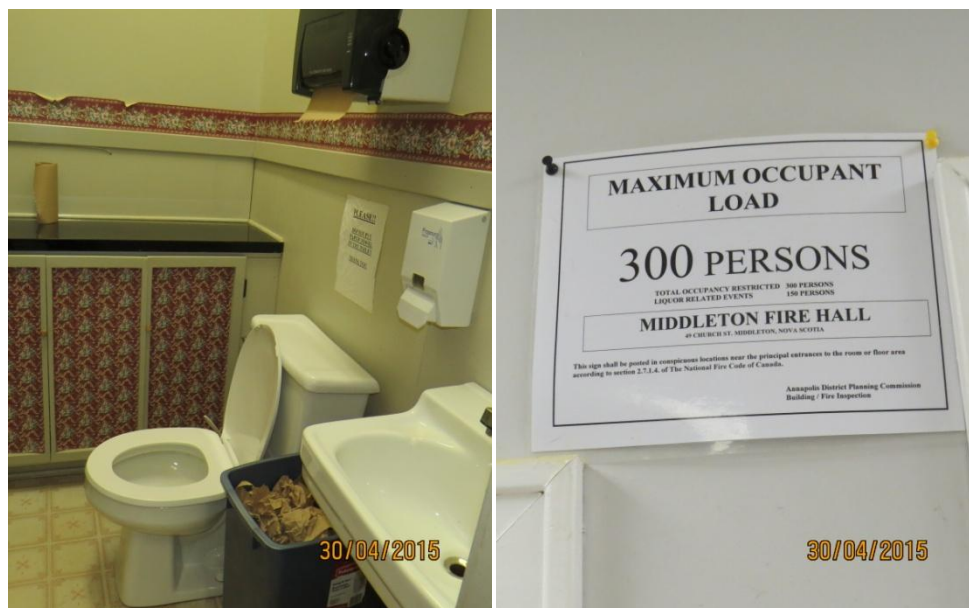
The men's is 2 urinals and 1 toilet, the ladies contains one toilet. The washrooms do not contain any shower facilities. The National Building and Fire codes require a minimum of 1 toilet and 1 urinal for every 10 men and 1 toilet for every 6 women. During regular daily activity, fire attendees being volunteers, the washroom facilities would meet common office operations. However; during usage of the common training hall the washroom facilities are not adequate to meet codes and standards. A common standard for fire emergency service properties is the ability for showers for the employees after a fire event. This property does not meet the standards.

Female washroom undersized for occupancy load

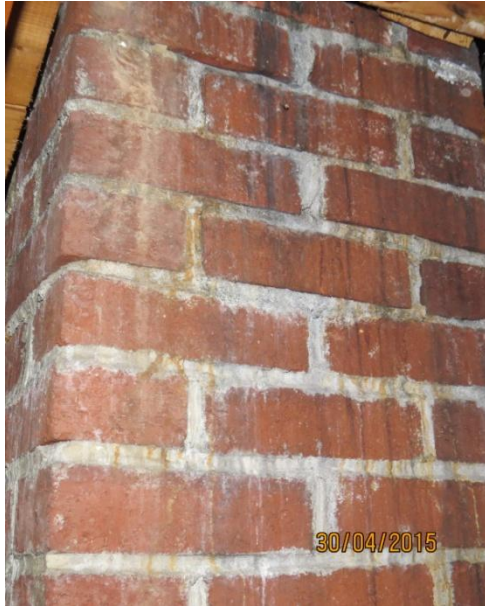
The heating system is hot water baseboard oil fired, a single heating boiler and a single 60 gallon how water tank are located within the boiler room. The majority of the piping system is not insulated generating great heat loss during operations. The chimney is leaking creosote from the boiler operations; the 2x 909 litre fuel storage tanks are located on the west side of the property between this property and the Town hall property near the main entry to the fire hall.

Chimney through attic leaking

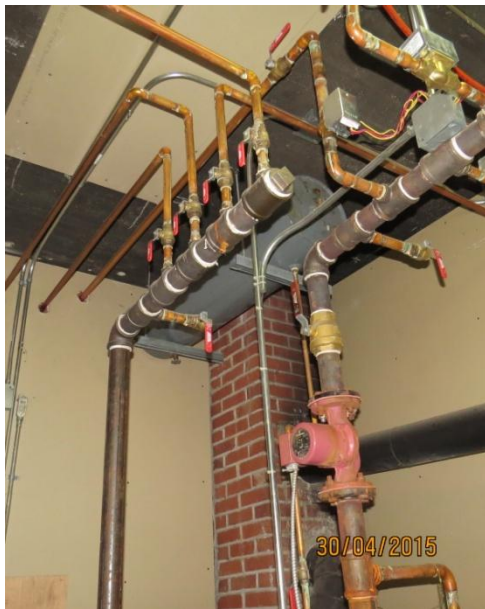
Non-insulated piping

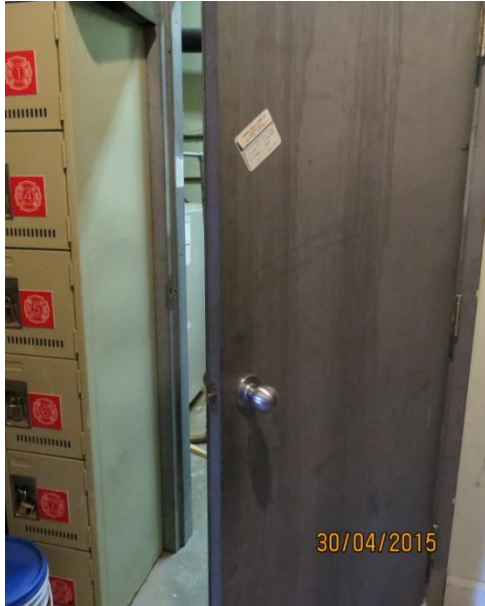
Boiler room door

The access entry door is a fire rated steel door and steel frame. However; under the codes governing this door entry system requires a door closure and latching device. This room also requires a CO and smoke detection service which does not exist.

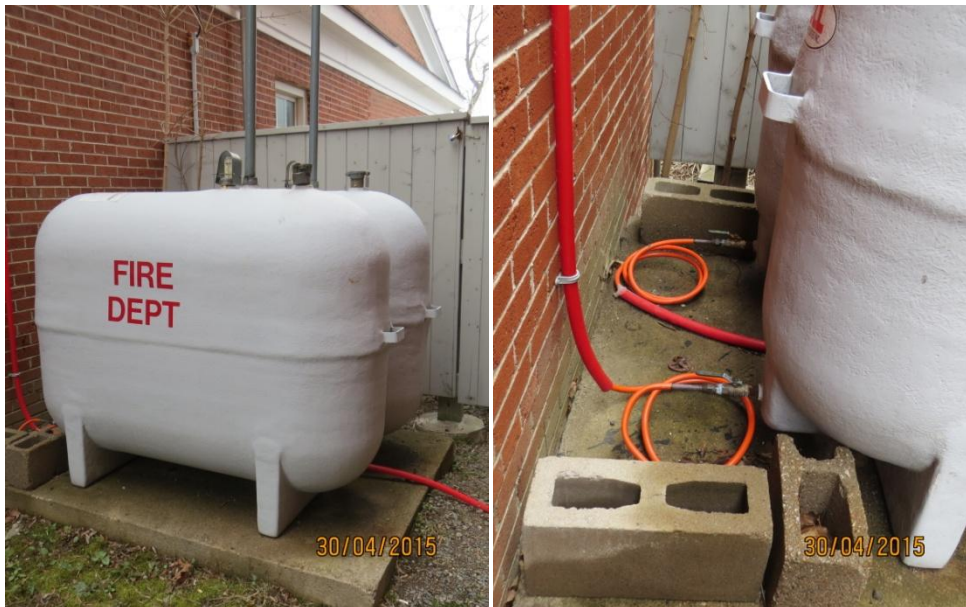
Heating fuel storage tanks

There are 2- 909 ZCL fibreglass double wall fuel storage tanks (manufactured in 2009) located on the west side of the property. The fuel supply line is not secondary contained and there is no overfill/spillage containment on the tanks. The tanks themselves meet code but the connecting apparatus (supply piping, filler pipe, etc.) does not.

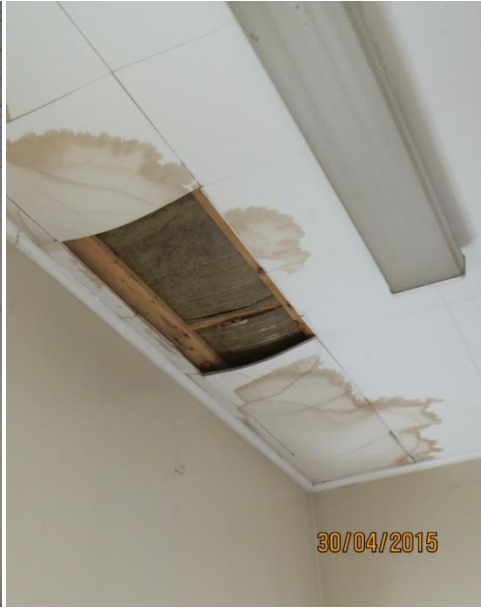
The suspended ceiling, near the north corner contains a substantial roof leak area very visible. The south end storage room ceilings contain several stains from past roof leaks.

storage room roof leak

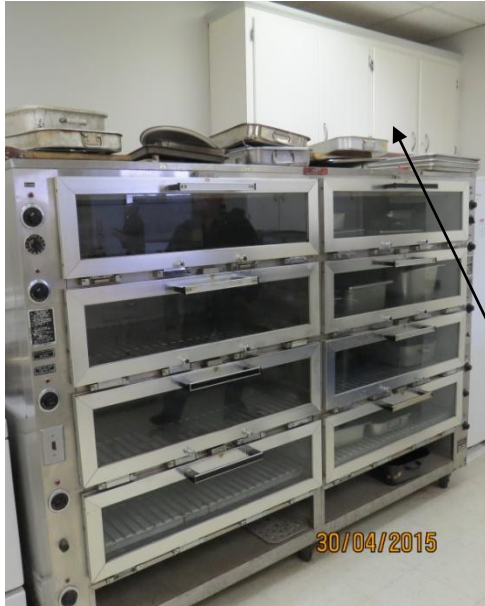
The kitchen is in reasonable condition but is missing key equipment to meet current codes and standards. An exhaust system is required for the commercial ovens, a CO and smoke detection system is required, wood and flammable products cannot be placed or stored in close proximity to ovens or other cooking appliances. The large commercial ovens should be certified to ensure there is no leakage or areas of concern considering the age of the equipment.

Wood and flammable products need to be relocated

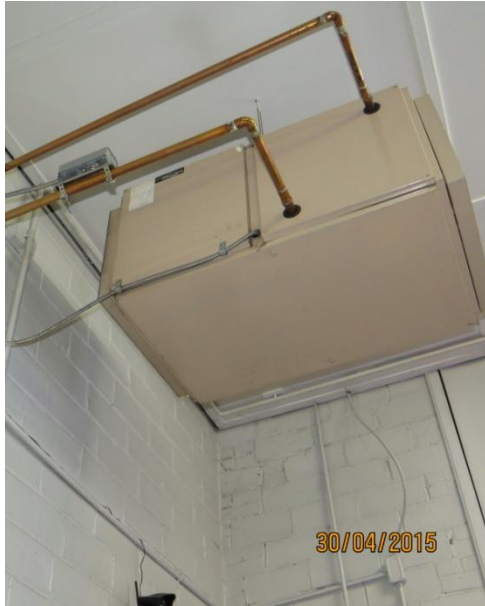
This property does not contain proper ventilation and exhaust systems. The kitchen contains a main exhaust with no grease collection, the fire vehicle storage does not contain an exhaust system, the common space (largest space) area is supplied by 2 ceiling mounted unit placed in the fire vehicle storage areas with 2 heat pumps located on the exterior east wall (Samsung model AQV36JAX). These units are of applicable size but being placed within the fire vehicle garage is a very poor location. These units require fresh air intake to function properly and they are circulating vehicle exhaust into common space.

Located in vehicle garage

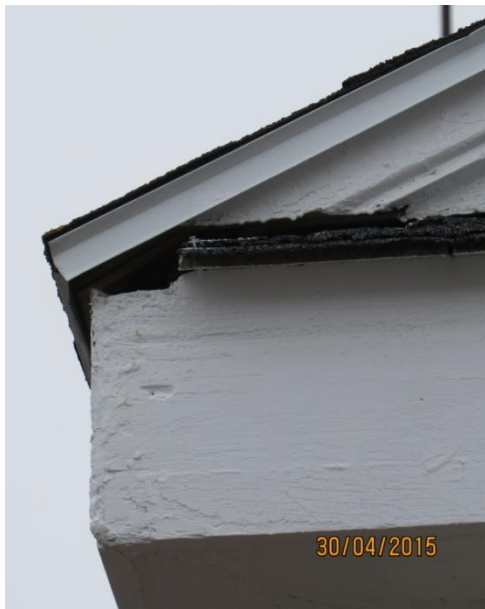
Left front corner

The majority of windows and doors are at various stages of decay requiring repairs. There are several areas of exposed flashing, missing sealant, mortar decay and general repair work required.

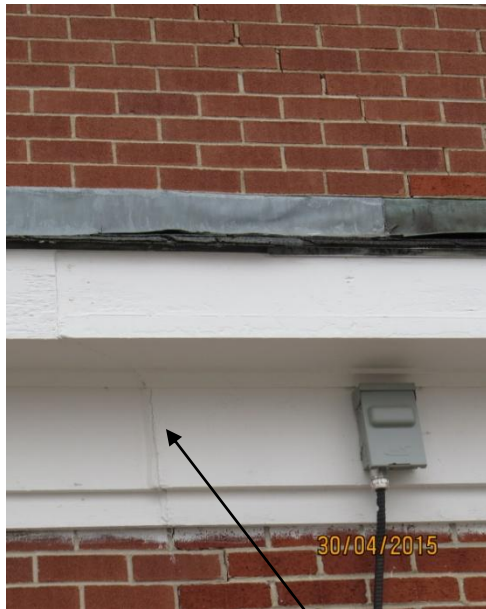
Water running behind fascia

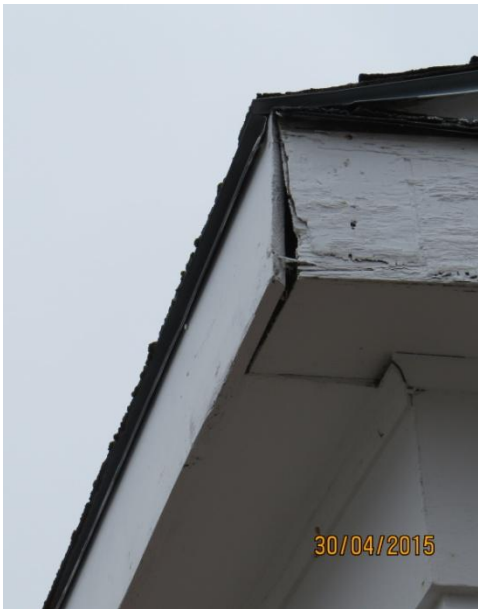
extensive decay to fascia and flashing

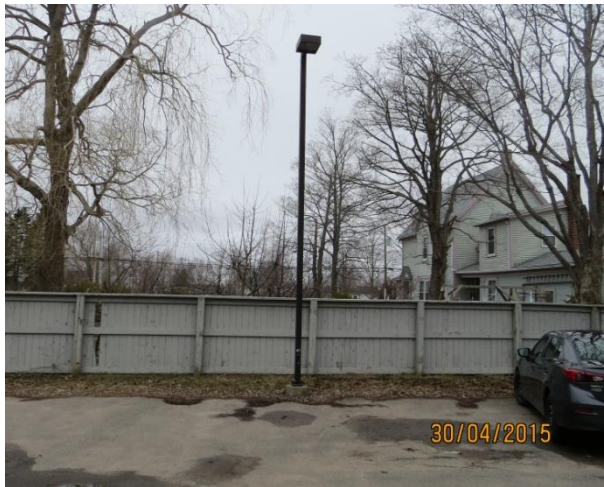
East side parking lot

The west asphalt area is shared with the Town Hall and is in poor condition (noted in Town Hall assessment). The north vehicle entry asphalt is fair to poor, the east side driveway is in good condition with minor repairs and the south end driveway is in good repair. The catch basin on the east driveway near the parking lot requires repairs.

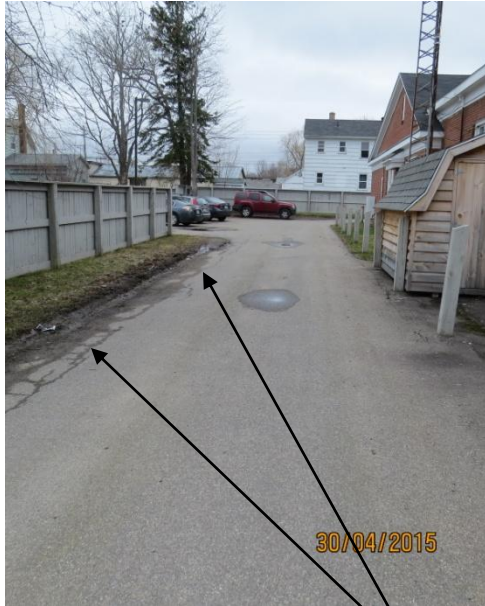
East side driveway- repair edging

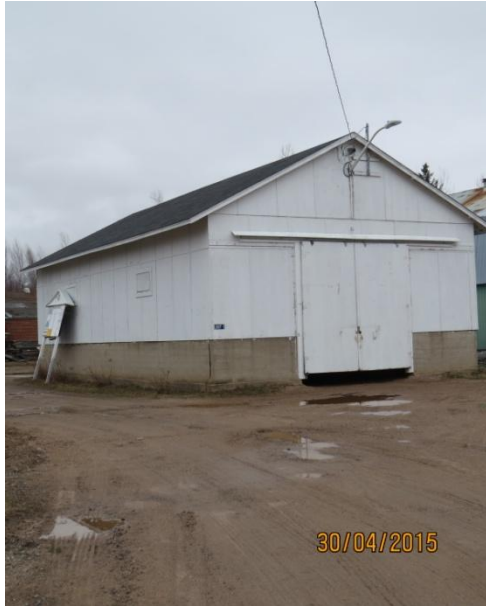
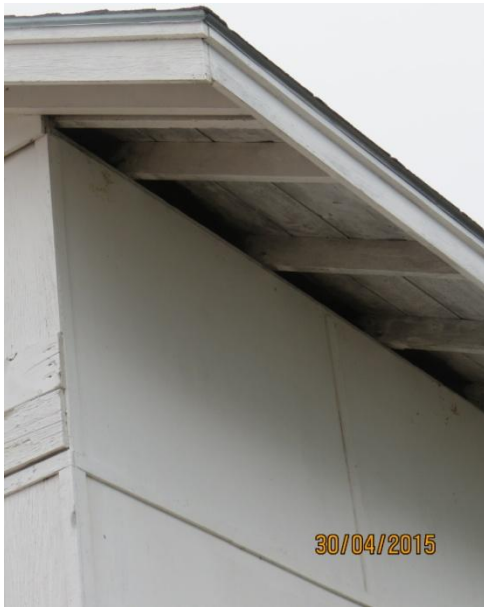
Open soffit ventilation

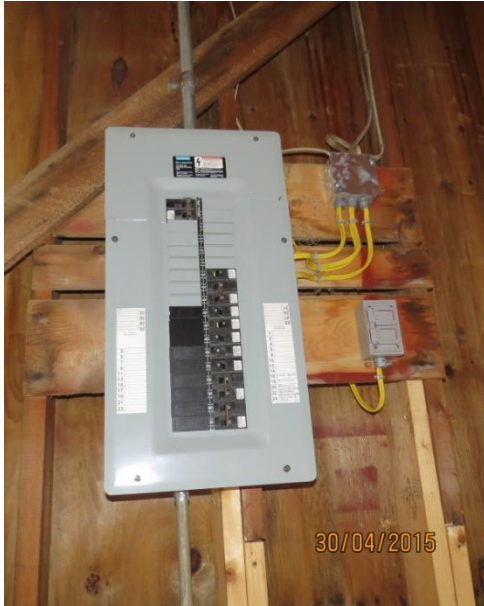
Panel not mounted to Code

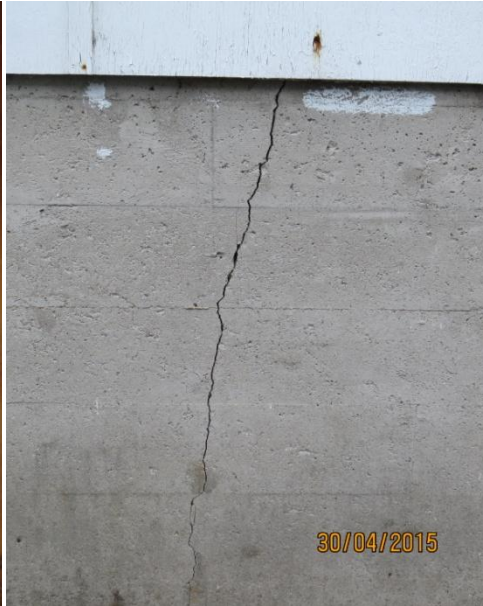
Structural crack in foundation

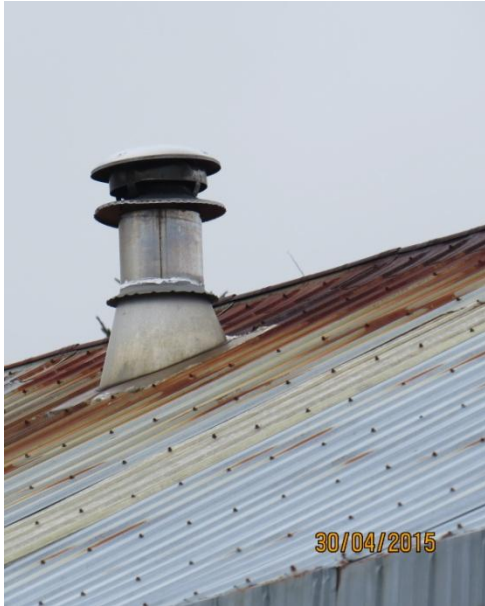
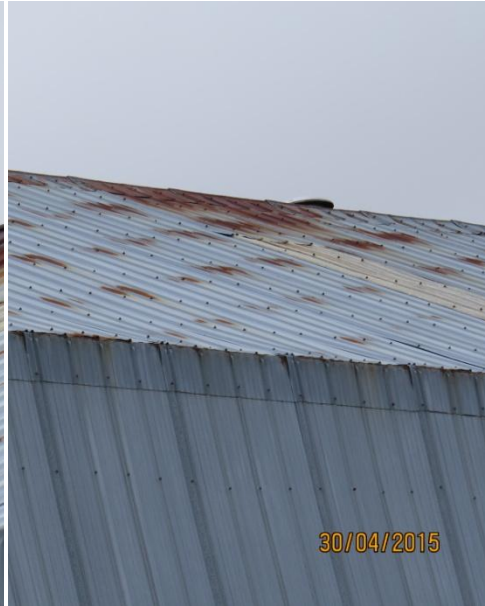
- 4.2 The metal siding is in fair condition, the metal roof is in poor condition and there are several large cracks in the poured in place concrete foundation. The large entry doors serve the purpose but do need constant repair due to age and usage.

Rusted roofing system

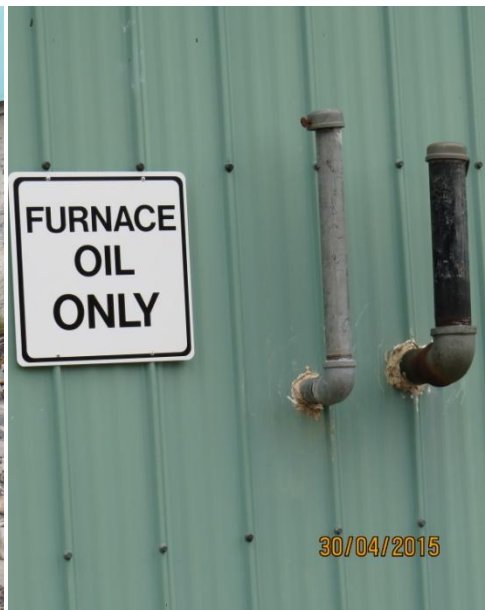
- 4.3 The building is heated with an oil fired boiler located on the upper floor and the 909 litre steel fuel storage tank is located inside the building on the lower floor. The fuel storage tank does not meet NSDOE secondary containment regulations. The fuel supply lines are exposed running several feet inside the building on the lower floor and extending up to the upper floor boiler. The fuel supply lines do not meet NSDOE secondary containment regulations.

heating system fuel tank fills and vent pipe

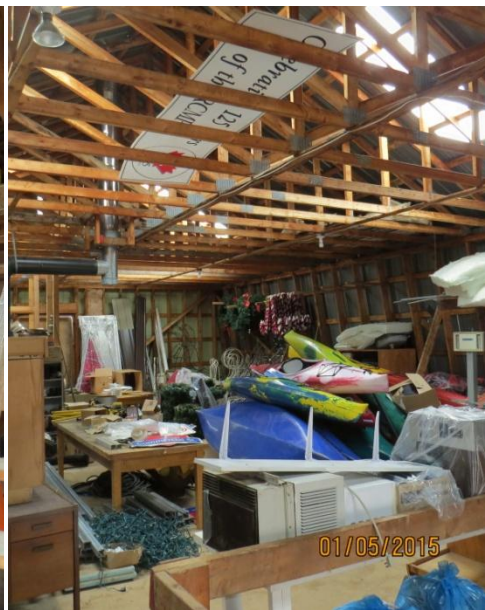
- 4.4 The building appears to be over crowded for the extent of materials, tools and equipment stored on site. We also noted several sections of products and equipment within the building which do not appear to have been used in an extended period of time. The products require additional shelving and organization to reduce hazards of falling products.

over crowded storage

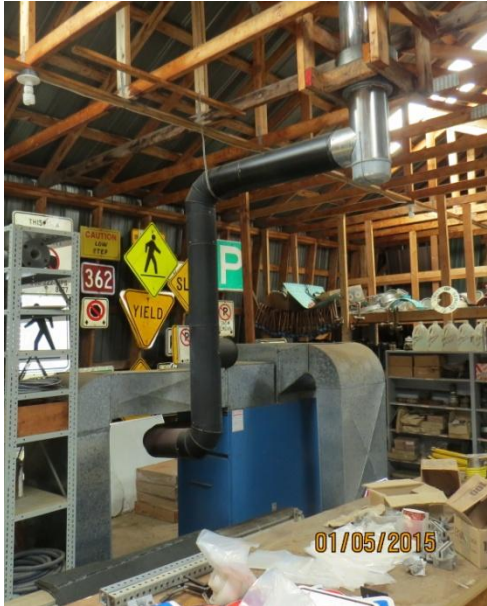
Gemini boiler and ventilation

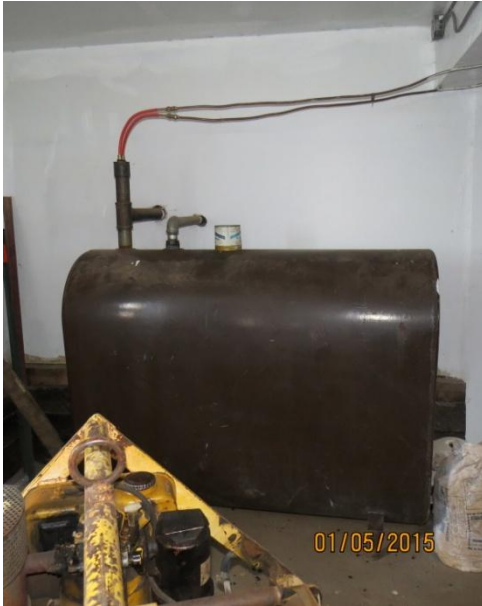
Unit 2 heating fuel- not to Code

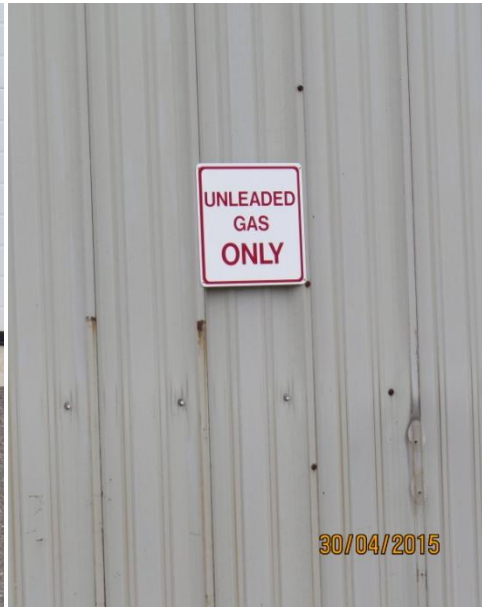
Former refueling area (east side)

Area	Issue	Priority	Cost	Notes
Structure	Walls and roof	2	75,000	Extensively aged, replace
Gasoline refueling	Decommission	1	TBD	Verify monitoring wells levels of contamination, if any.
Second floor	Access stairs	1	2500	Not to code, old and weak
Relocation of products	Over crowded	1	In house	safety
