Town of Middleton

Facility Assessment and Capital Planning- Final submission

Eagle Project Management Inc.

Facilities Assessment and Capital Planning

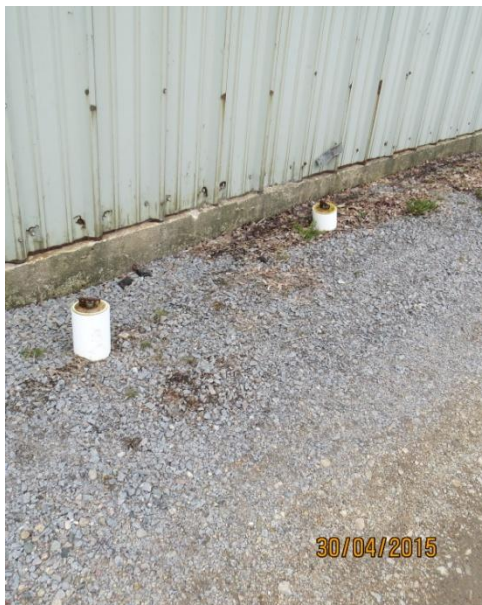
Former refueling center monitoring wells

Area	Issue	Priority	Cost	Notes
Structure	Walls and roof	2	75,000	Extensively aged, replace
Gasoline refueling	Decommission	1	TBD	Verify monitoring wells levels of contamination, if any.
Second floor	Access stairs	1	2500	Not to code, old and weak
Relocation of products	Over crowded	1	In house	safety

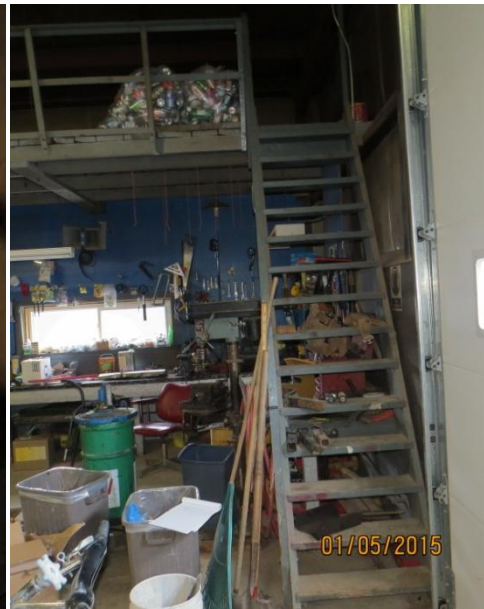
over crowded work space

6.3 We are concerned with the restrictive working conditions for employees when considering the large quantity of equipment, materials and tools stored at this location.

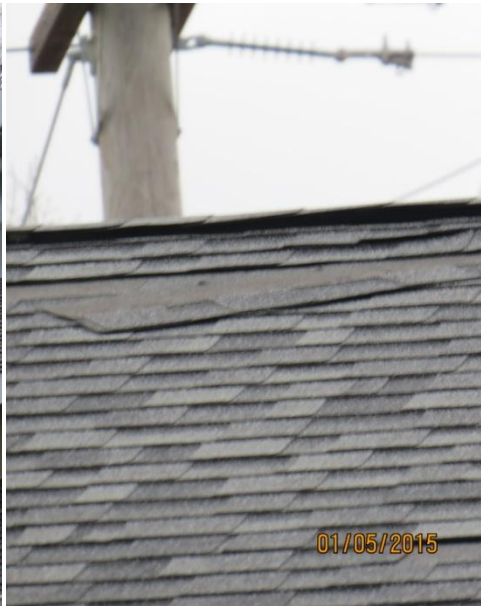
This overall building appears to be in good condition with some areas of capital improvement/repairs required. The shingle roof system is failing, two cracks were found in the masonry and the larger equipment door requires general repairs.

Front elevation- lose shingles

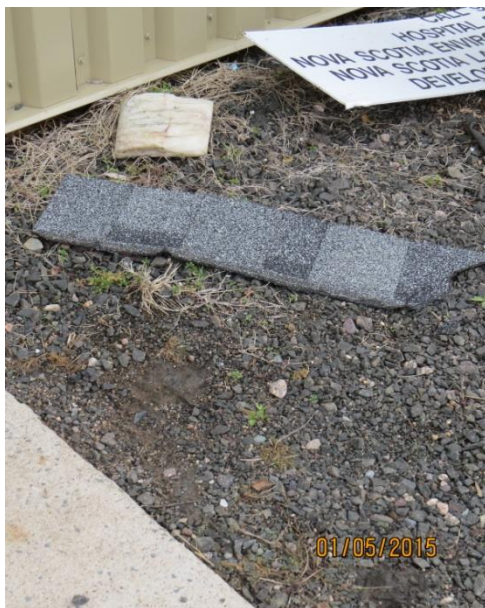
Shingles on ground

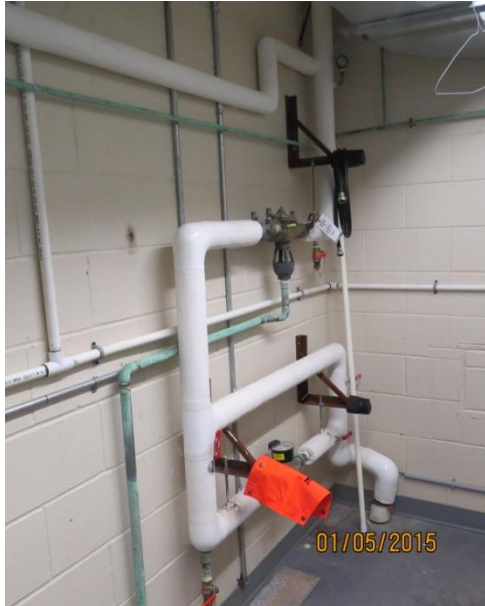
The backflow prevention device was last tested on March 27, 2012 and is a 1-1/4" Watts system. NSDOE Regulations require backflow preventers to be certified annually.

Backflow preventer not certified

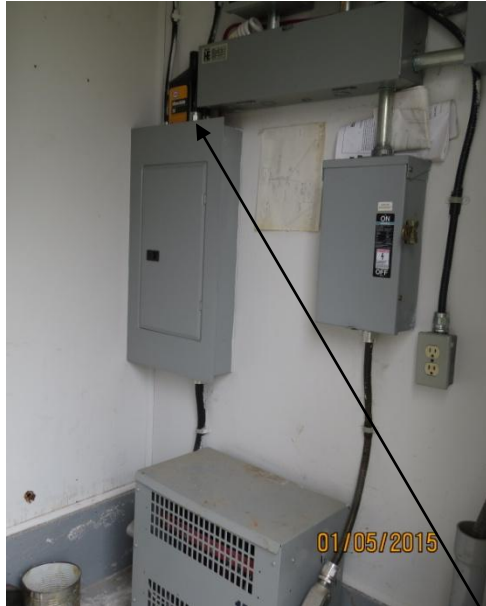
Main electrical for auger (remove oil can)

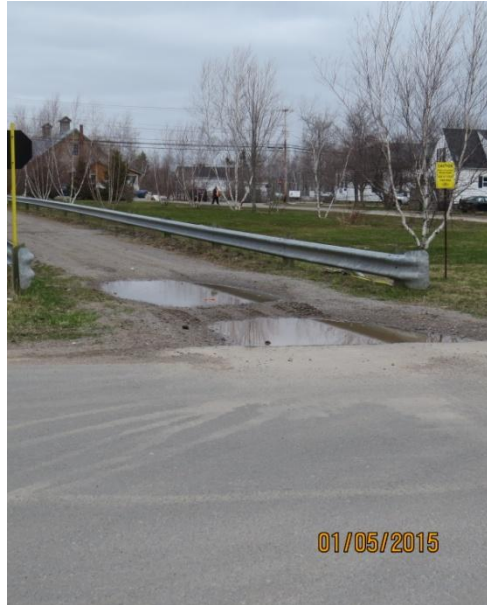
Common pot holes near roadways

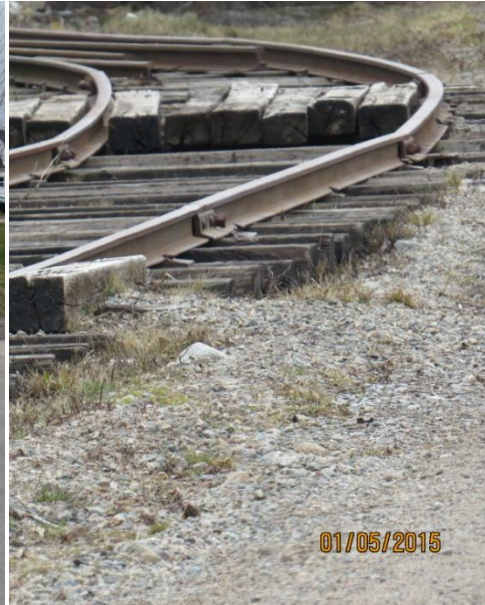
Pedestrian hazard near rail museum

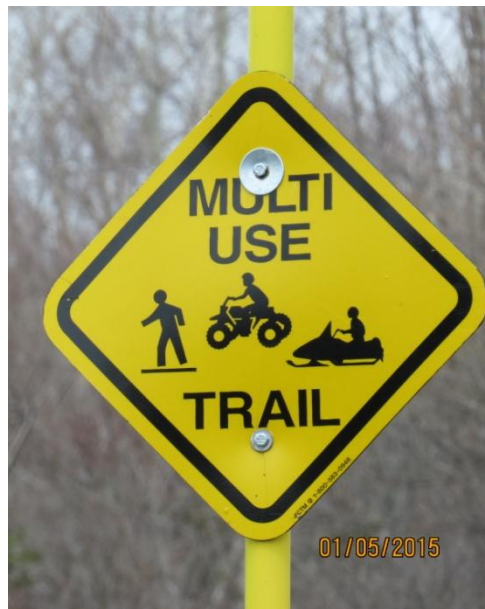
Only 2 of these signs found

- Install “use at your own risk” at all entry points from Town boundary lines and where public streets intersect trails. 17 required
- Install “no motorized vehicle” signs at all public road crossings and at Town boundaries, 17 required in total, 2 found posted, total new 15. **Contradiction:** During initial Town meetings it was clearly noted motorized vehicles are not permitted on the trails. However; signs are posted permitting motorized vehicles- ATV, snowmobile, etc. Town policy and liability should be reviewed and signs posted reflecting liability/non liability. I.e. potentially reducing town liability by posting signs with same message located at all entry points.
- Install “end of Town limits” at trail/Town boundary points (TRA Transport, Annapolis River bridge, end of Senator Street), 3 required.
-

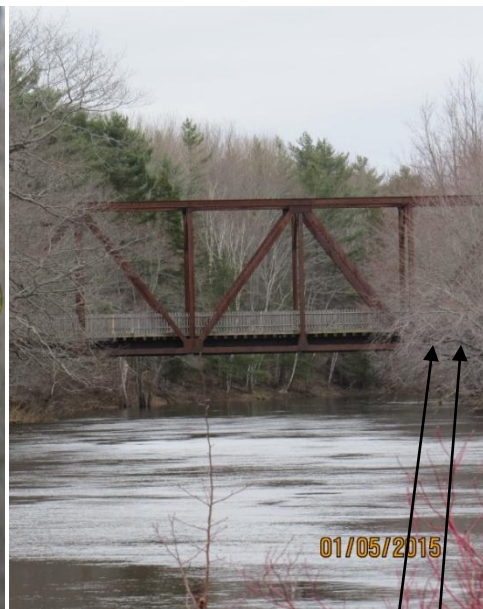
Town boundary limit

Former Rail Bridge, not part of Town maintenance program, posting of signs required.

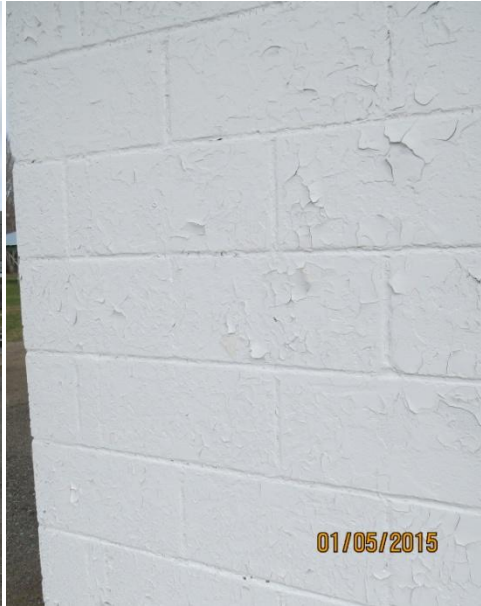
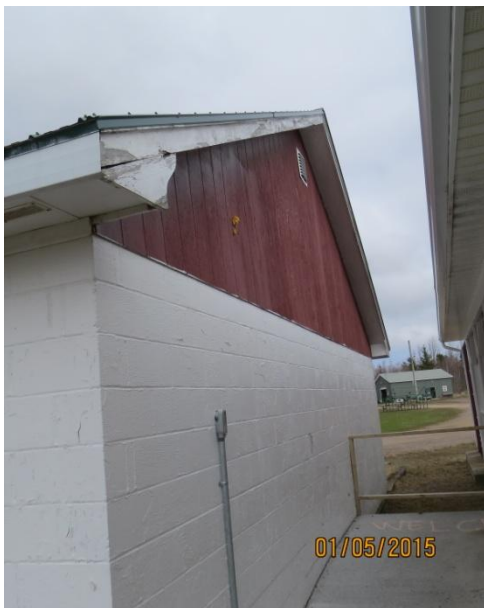
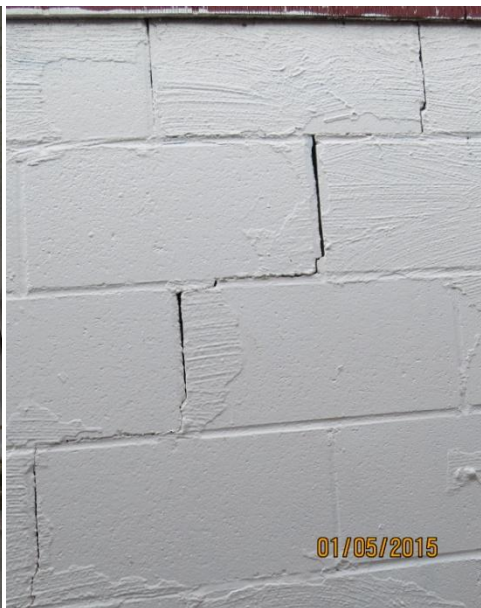
- 1.1 The roofing system is a prefinished metal installed approximately 5 years ago and in good condition. The masonry block walls contain cracks associated with movement, ice and general climatic conditions. The floors are concrete and in good condition.

Cracks in east wall

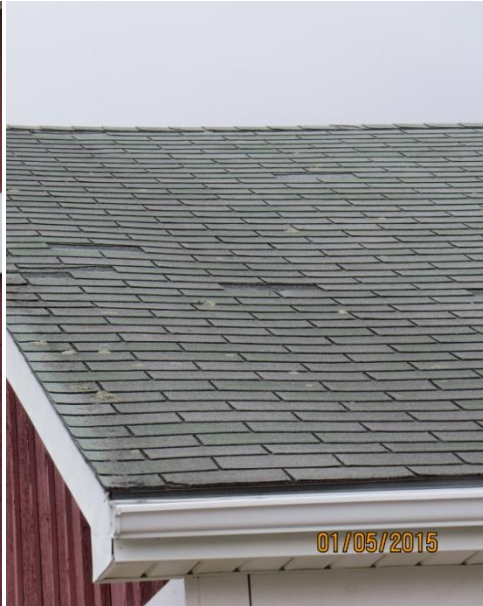
east roof- several shingle missing

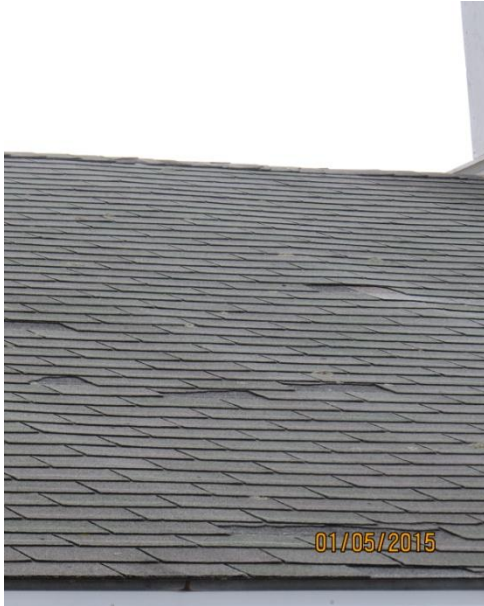
West side roof several shingles missing

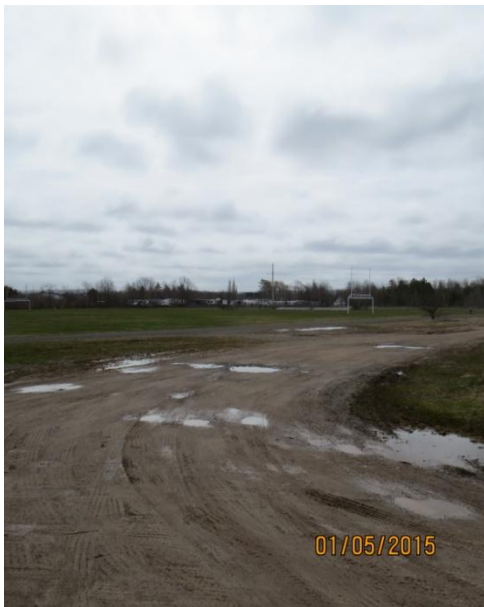
The gravel track is in good condition and requires minor winter /spring maintenance to make ready for full summer use.

View of general road and track- maintenance required

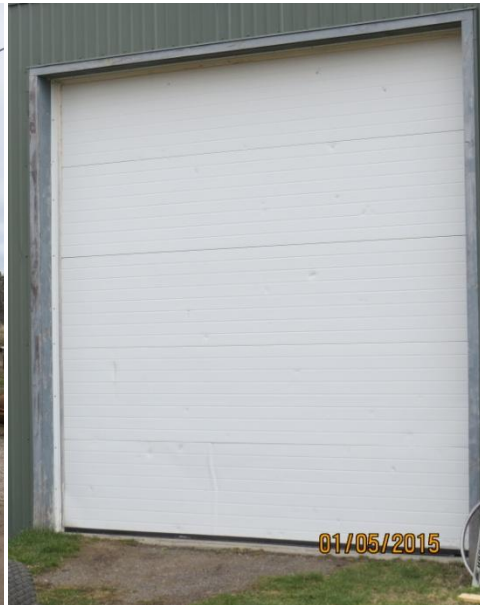
loading door needs minor repairs

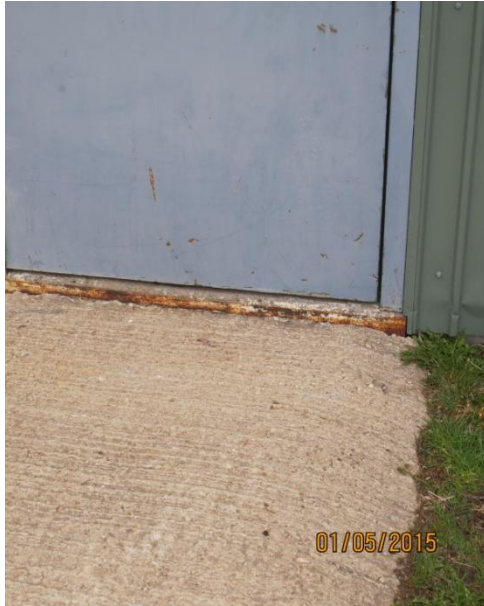
Pedestrian door needs minor repairs

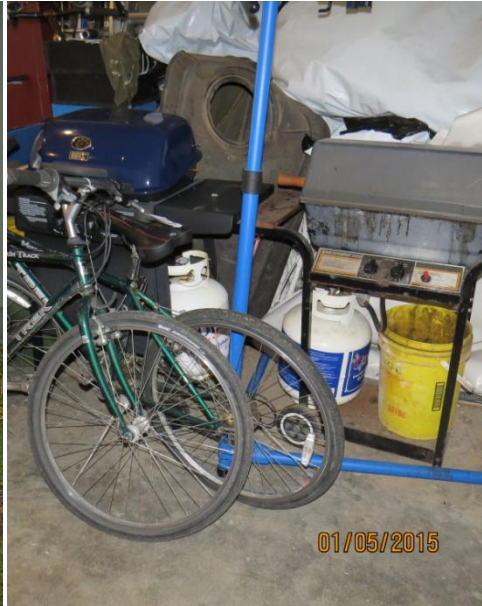
5.12 Portable propane tanks are not permitted to be stored inside a building (NFC). They must be placed outside and secured.

improper storage of propane tanks

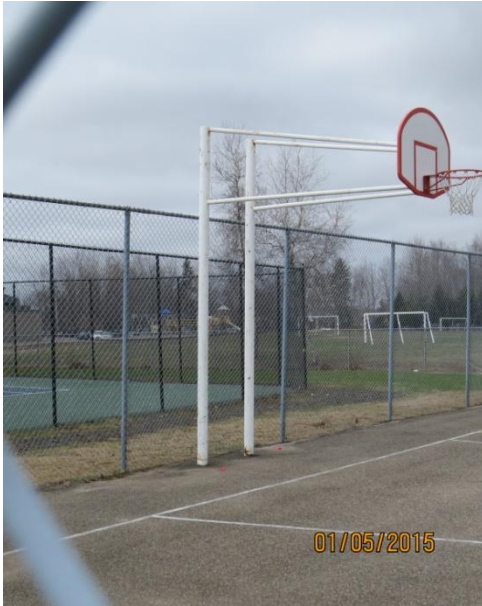
The basketball court is in good condition requiring minor maintenance such as painting of the steel support structures.

Painting required

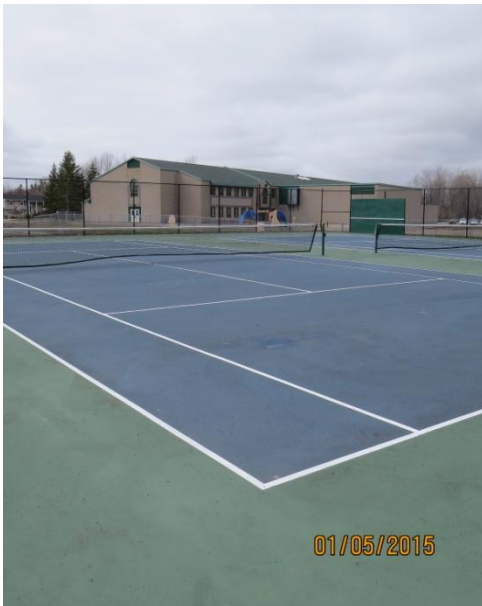
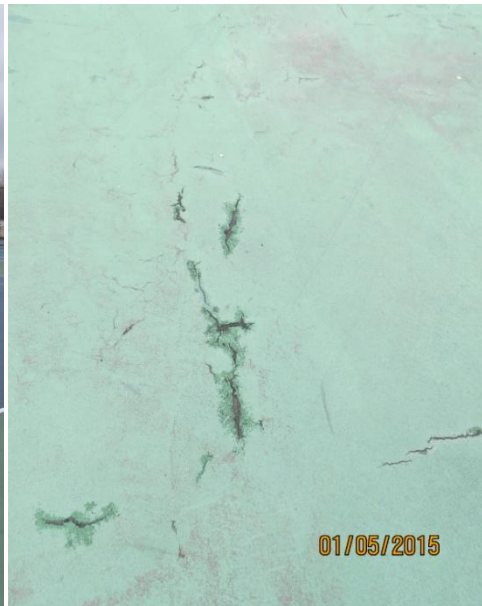
Minor maintenance required to the surface areas. Minor paint delaminating is a few areas.

Paint flaking

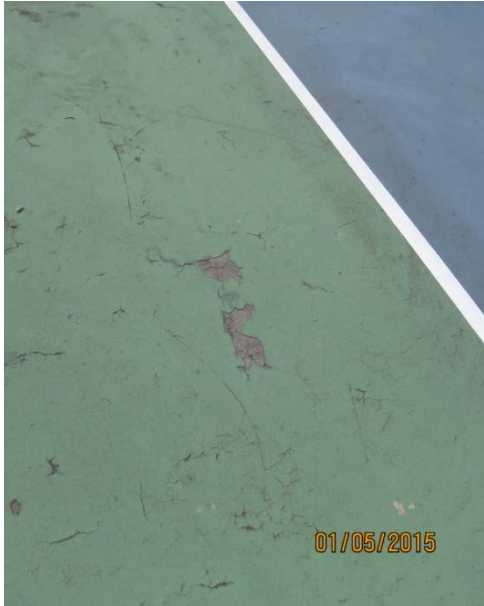
Paint flaking

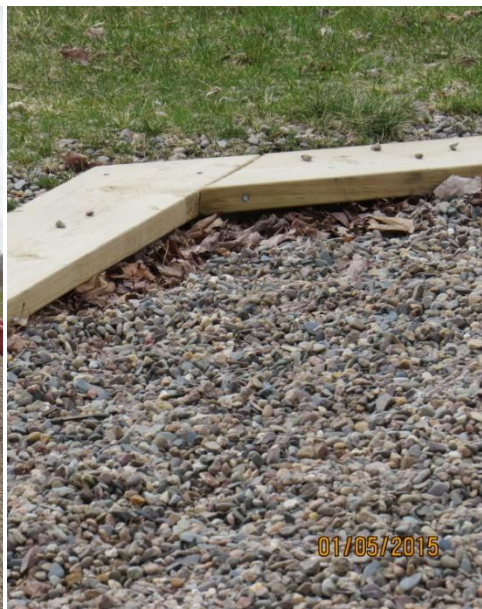
This structure appears to be in fair to good condition but is showing signs of aging. Several sections of the equipment require refinishing and refurbishing to ensure longevity. The structures themselves appear to be in good working order. The gravel enclosure requires minor maintenance to reset the gravel and remove the tripping hazards.

re-grade gravel- remove tripping hazard

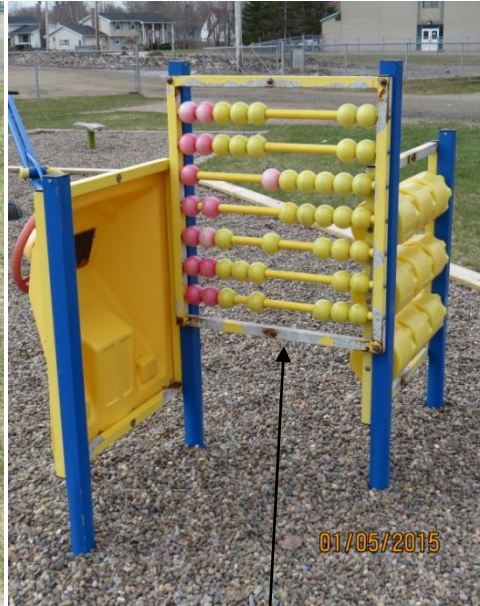
Rust on structure

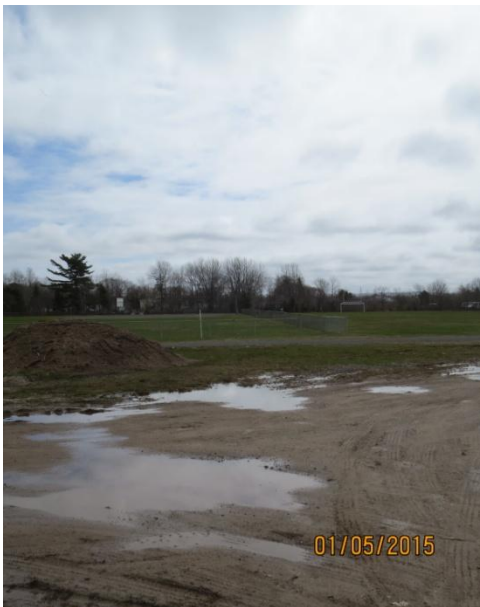
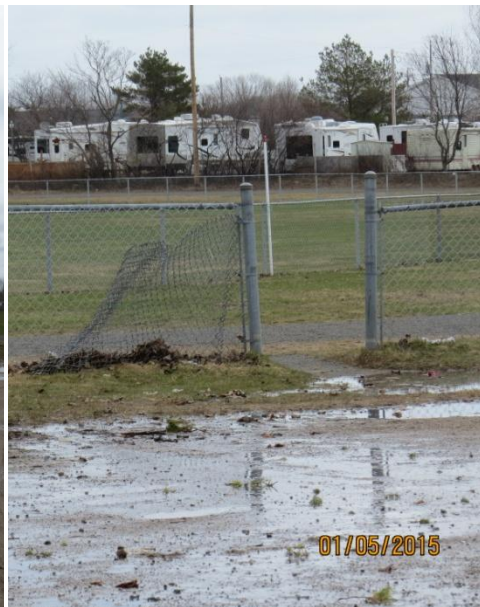
The parking areas are in good condition but do require maintenance after the winter snow melt. Several pot holes and loose garbage.

Fill gravel holes- general maintenance

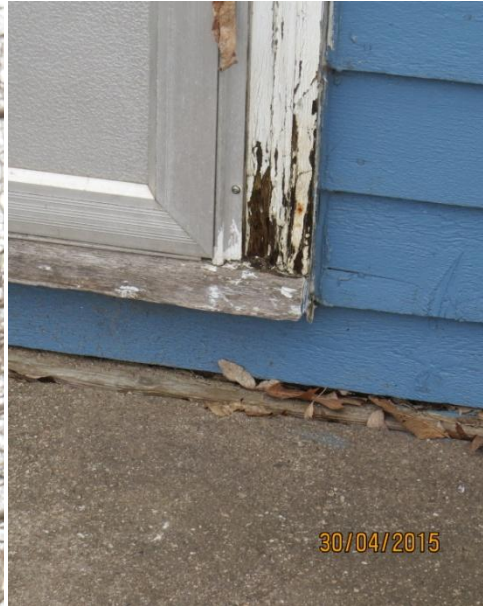
There are small areas of concern which should be address which include the main entry wood door and wood frame has decayed, the wood soffit requires minor repairs, the concrete blocks supporting the structure have shifted. The flag pole system requires repairs and painting, the pole is slightly tilted.

replace wood door and wood frame

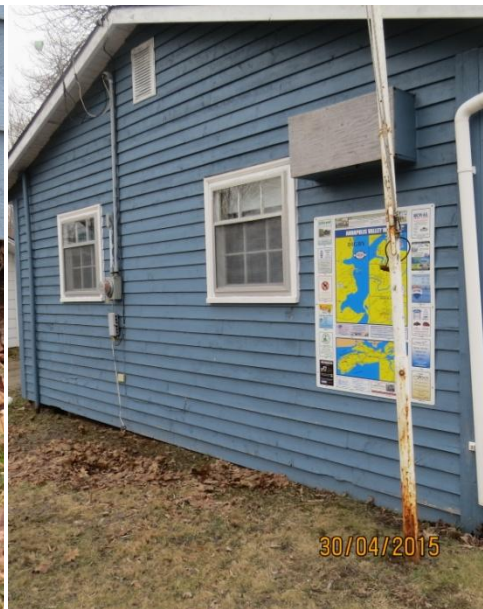
flag pole- adjust and paint

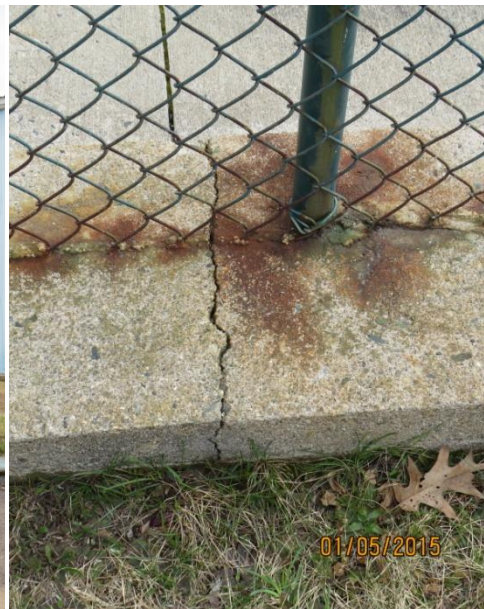
- Various cracks and sections missing in and around the perimeter of the pool structure.
- Lifeguard safety stations in fair condition
- Visitor bleachers/stands fair at best, loose boards
- The chain link fencing appears in good condition

typical pool perimeters

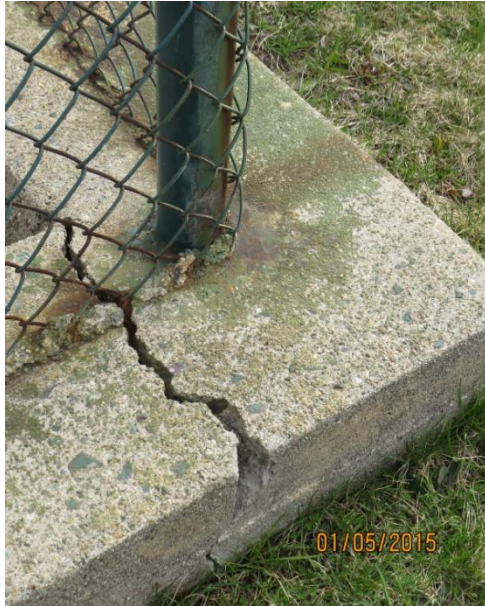
Pool parameter

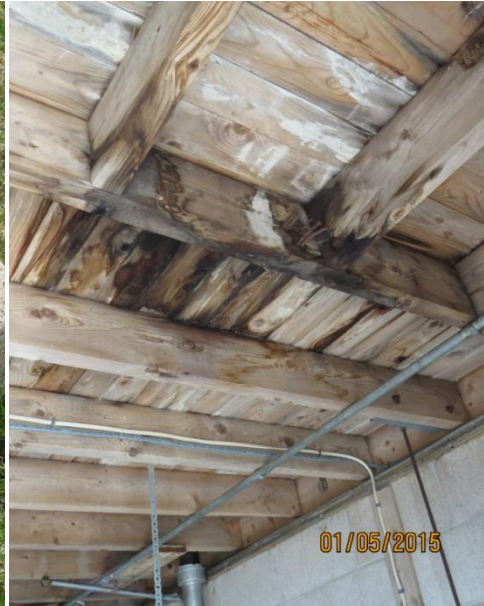
- The concrete block constructed building is in poor condition with extensive amounts of block joint failure, stress delaminating, and stress crack flaws very visible.
- The tar and gravel roof system is leaking in 3 known areas, primarily the northeast end of the building (mechanical room areas)
- The fuel storage tank is a single layer steel tank not protected from leaks, no secondary containment

Leaking roof
